Research article

Effect of hygrothermal conditioning on the mechanical and thermal properties of epoxy grouts for offshore pipeline rehabilitation

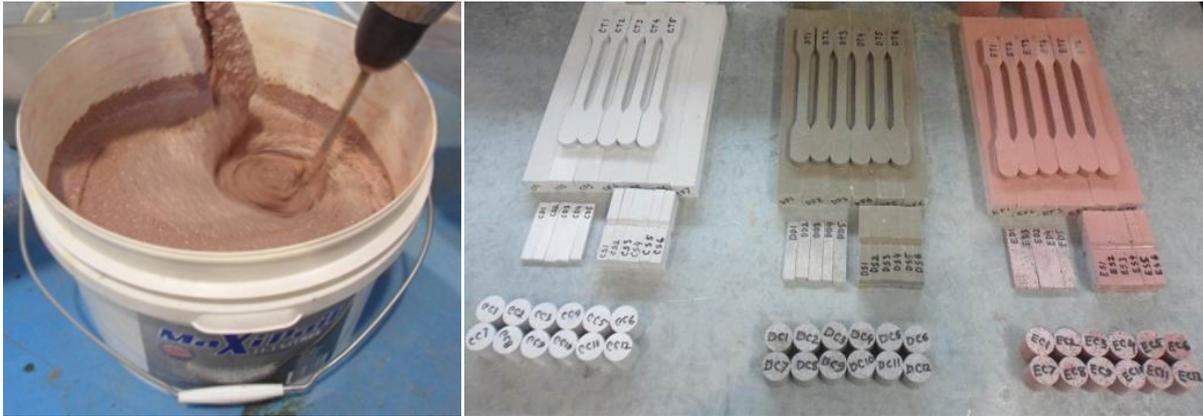
Figure 1. Preparation of specimens. (a) mixing of the grouts and (b) part of typical test specimens.

Respective parts of the grout systems were mixed volumetrically and by weight according to the guidelines stated in the respective Technical Data Sheets. A hand held electric drill mixer was used to mix the volumetric batch in a plastic container. Freshly mixed grouts were poured into moulds within their respective allowable mixing periods at 23 °C. Freshly mixed grouts were poured into the designated moulds. Figure 1 shows the mixing of typical grout EG3 and part of the grout specimens. The specimens were cut and polished to the required dimensions. Table 2 summarises the details of specimen dimensions and tests conducted on the prepared specimens. The specimens were removed from the moulds after 24 hours and cured in a controlled environment at 23°C for 7 days prior to hot-wet conditioning.

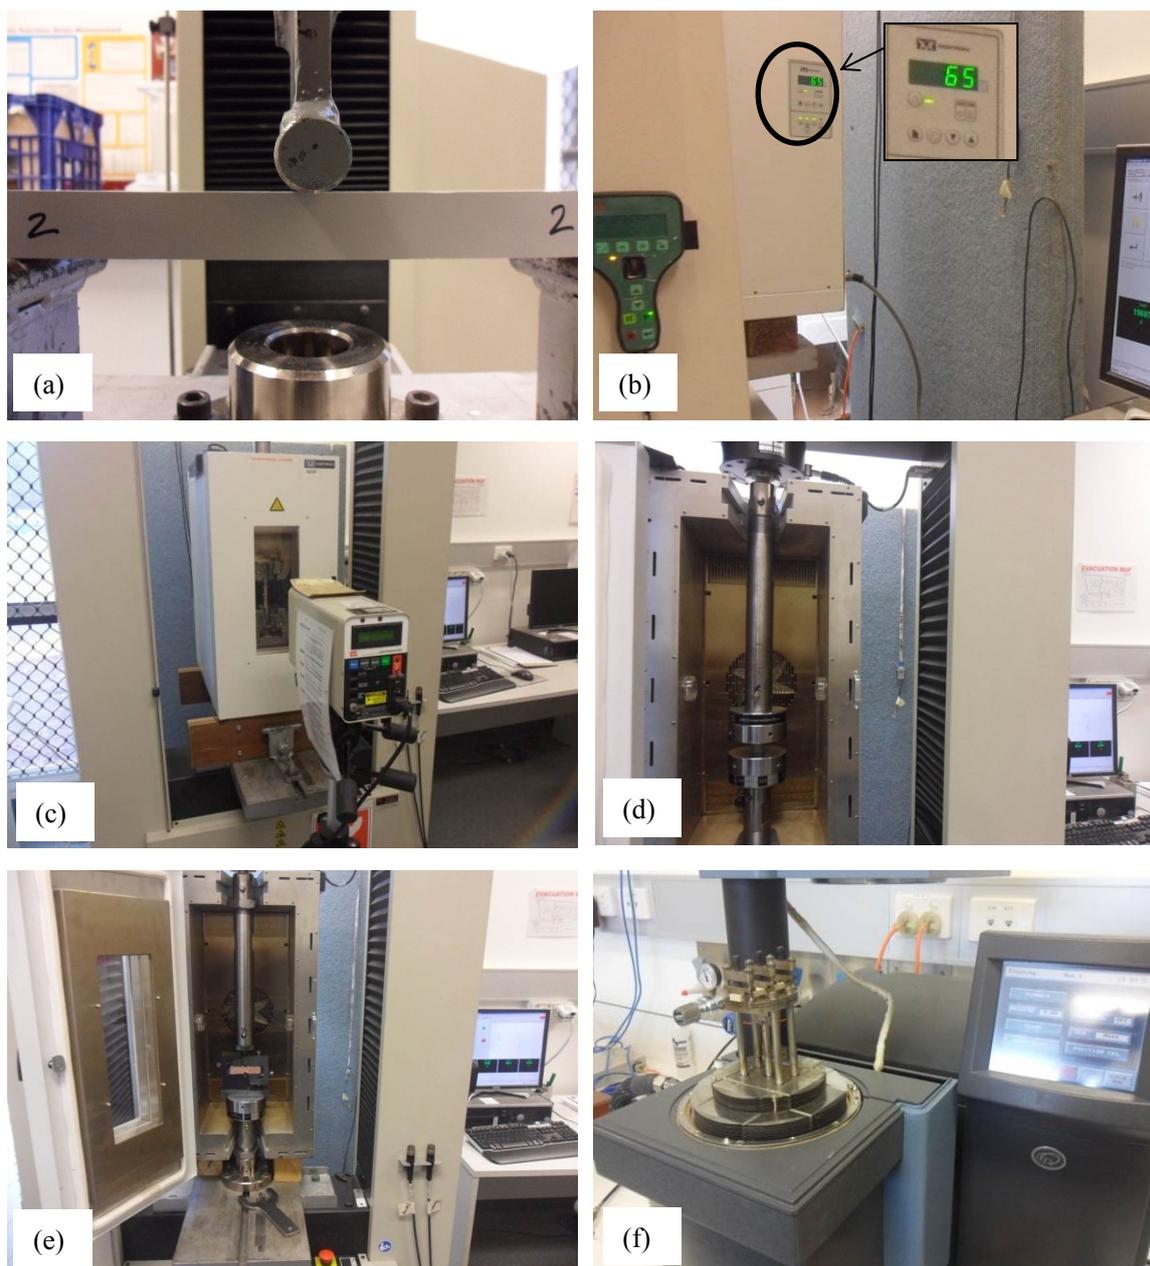
Figure 2. Testing of the grouts; (a) flexural test at room temperature, (b) elevated temperature, (c) tensile test underway at elevated temperature, (d) compressive test setup inside chamber, (e) typical shear test setup inside chamber, and (f) DMA specimen mounted in test machine.

A laser extensometer was used to measure the strain data for tensile test. Iosipescu shear test was carried out using shear test fixture by Wyoming Test Fixtures Inc. at negligible normal stresses. The fixture is such that a condition of pure shear was introduced at the middle of the specimen by applying two counteracting moments. The hot-wet conditioned specimens were preheated in a water bath by placing in an oven for at least 30 minutes prior to being placed into the temperature chamber for testing. The test started once the chamber temperature reached 65 °C and was maintained for 10 minutes. The specimens were tested at 65 °C as it was irrelevant to test them at 70 °C, since the glass transition temperatures for the all the conditioned specimens were found below 70 °C. Moreover, this temperature is within the specified temperature range suggested by ISO/TS 24817.

Dynamic Mechanical Analysis (DMA) was used to determine the glass transition temperatures of the grouts as suggested by ISO/TS 24817. A DMA Q800 with Universal Analysis 2000 V5.1 Build 92 manufactured by TA Instruments was used to carry out the tests. The specimens were clamped in the three-point bending fixture of the DMA apparatus with effective span length of 35 mm. Figure 2(f) shows the mounted DMA specimens on the DMA apparatus. The heating rate was 1°C/min starting from room temperature to 140 °C.

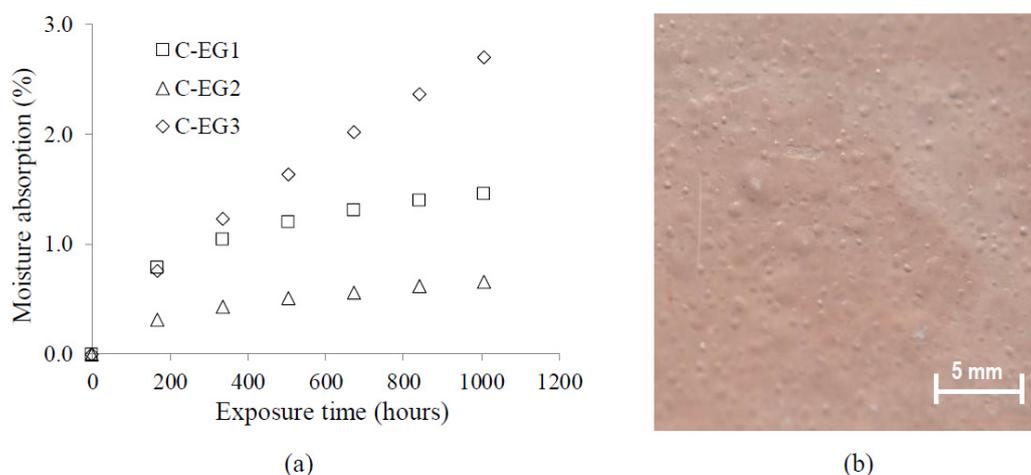
Figure 3 shows the moisture absorption trend of the grouts over the 1000 hours conditioning period. Moisture content is presented against immersion time in hours. The moisture content is calculated for 25 mm cylindrical specimens. If the moisture absorption of the grouts is compared, the highest absorption is observed for grout EG3 with a value of 2.7% after 1000 hours. The trend suggests that EG1 and EG2 grouts reached equilibrium by 1000 hours. However, an increasing absorption trend in the grout EG3 at 1000 hours indicating that 1000 hours may not be sufficient to achieve complete saturation as suggested by ISO/TS 24817. The lowest absorption is found for grout EG2 with values ranging from 0.66%. The trend of the moisture contents of the grouts suggests that absorption rate is the highest during the first 168 hours (7 days) and decreased thereafter for grouts EG1 and EG2, whereas the absorption increases with time for grout EG3. The behaviour is mostly due to the absorption of water molecules in the intrinsic hole volume [15].

Figure 3. Moisture absorption in grout specimens, (a) Effect of exposure time on absorption, and (b) formation of blisters on grout EG3.

The hot-wet conditioning resulted in a mild change in colour on the surface of the grouts. Most notable physical change occurs on the surface of the grout during the absorption process is the formation of blisters on the surface of grout EG3. Formation of blisters on the grout EG3 is shown in Figure 3(b). This might happen due to the swelling forces of the absorbed moisture which forced out of the surface of the specimen.

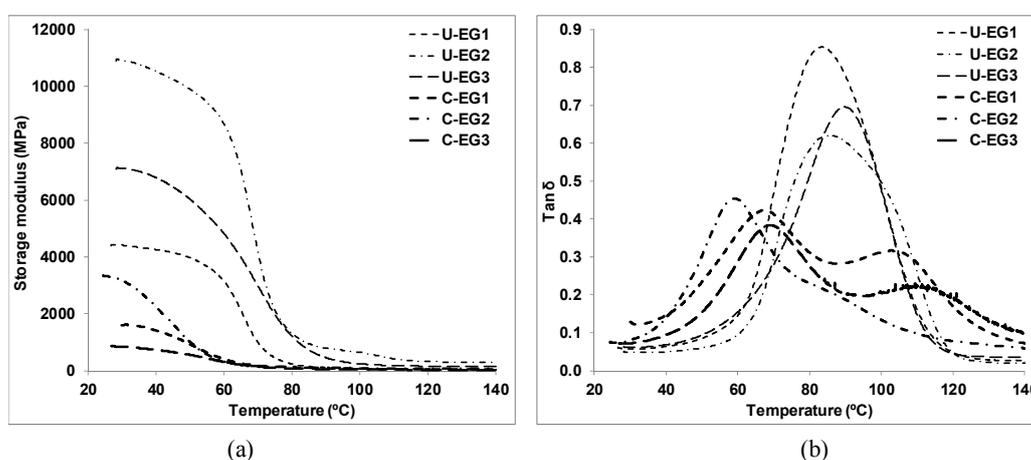
A superposition of the storage modulus and $\tan \delta$ is shown in Figure 4. Storage modulus inflexion (T_g) provides lower glass transition than $\tan \delta$ peak (T_i) for both unconditioned and conditioned grouts. This behaviour is also comparable to Goertzen and Kessler [16]. The conditioned grouts show distinct secondary $\tan \delta$ peaks. This phenomena related to exposure to higher temperatures is due to the dominant re-arrangement of the molecules resulting in the formation of much denser crosslinking structure [17].

Figure 4. Thermal plots to determine glass transition temperature (a) storage modulus vs temperature, and (b) $\tan \delta$ vs temperature.

The T_g and T_i in the unconditioned grouts range between 53–59 °C, and 83–90 °C, which range between 39–42 °C, and 59–69 °C, respectively for the conditioned grouts. The highest value of $\tan \delta$ is observed in the unconditioned grout U-EG3 with a value of 90 °C which is found to be 83 °C for grout U-EG1. On the other hand, the highest value of $\tan \delta$ peak is also found in the conditioned grout U-EG3 with a value of 69 °C which is about 2 °C higher than that of grout U-EG1. Hence, the lower resin content in grout EG3 does not reduce its glass transition temperature. However, as the storage modulus was recorded from the room temperature, the tangent of the initial storage modulus could not be drawn. Hence, a horizontal line is considered as the initial tangent line which intersects with another tangent line drawn from the decreasing storage onset to determine the T_g .

The $\tan \delta$ peak, T_t of the conditioned grouts is found to be about 60–70 °C, which is about 20 °C lower than the unconditioned grouts. Again storage modulus, T_g is also reduced by about 20 °C when conditioned. This implies that hot-wet conditioning reduced the glass transition temperature of the grouts. Elevated temperature in conjunction with moisture were found to reduce the glass transition temperature by a range of 9–25 °C, hereby the service temperature in an intensive study on a number of epoxy grouts for structural application [29]. Hence, the mechanical properties are affected by the hot submerged condition (70 °C) and elevated temperature, which is above their glass transition temperature as determined by storage modulus. It is evident that the appropriate glass transition assignment approach used here, taking the peak of the $\tan \delta$ curve (T_t), is less conservative approach than taking the onset of decline in the storage modulus (T_g). Furthermore, T_g and T_t are found to reduce by approximately 20 °C after hot-wet conditioning, which for instance justifies the 20–30 °C temperature buffer used for Type A and Type B pipeline repairs, based on the guidelines presented in ISO/TS 24817. Hence, further investigation on the properties is suggested considering the T_g instead of T_t of the unconditioned specimen as benchmark.

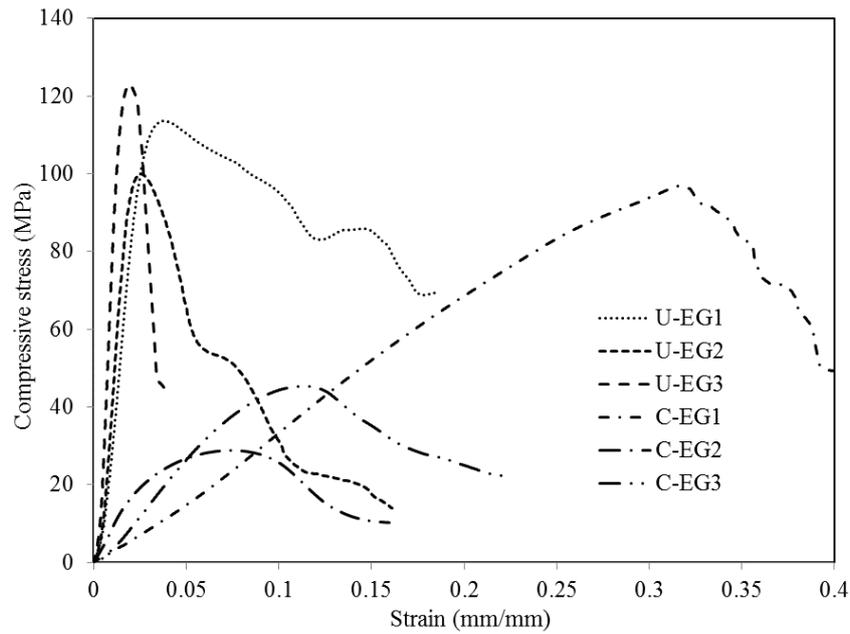
Figure 5 shows the comparison of the typical compressive stress-strain behaviour of the compressive specimens. The epoxy grouts show an elastic behaviour followed by yield stresses. The relative deformation in the conditioned specimens are clearly much higher compared to unconditioned grouts. The yield strain of U-EG1, U-EG2 and U-EG3 are 3.4%, 2.3%, and 1.9%, respectively, which increased to about 32%, 8%, and 11%, respectively after hygrothermal conditioning.

Figure 5. Typical stress-strain behaviour of compressive specimens of the grouts.

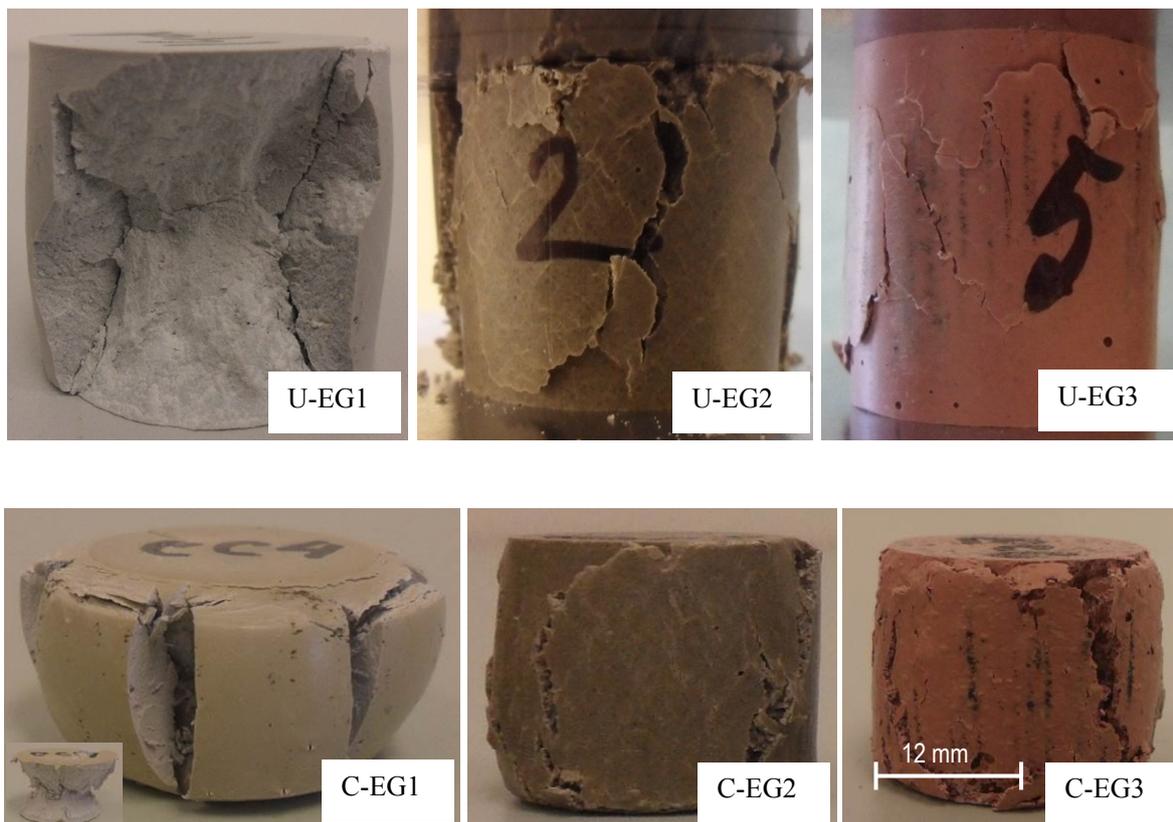
Figure 6 demonstrates the typical failure patterns of the unconditioned grouts under uni-axial compression. Under compression, grout U-EG1 exhibits peripheral bulging after the initial elastic behaviour. The orientation of cracks in the outer shell of grout U-EG1 is vertical. District cup-and-cone failure is observed for both U-EG1 and C-EG1 specimens. The bulging proceeds until failure which is initiated by vertical cracks. However, the bulging in the C-EG1 is comparatively higher than that of the U-EG1. The failure wedges in the compression specimens form at an angle of about 45° with the vertical axis for both conditions. The bulging starts after the linear elastic zone of the stress-strain curve. However, for the grout U-EG1, following yield and the accompanying reduction in stress, there is an increase in stress, but not beyond the peak stress. This is due to the meeting of the failure wedges at prolonged strain. The cracks in the grouts U-EG2 and U-EG3 specimens are sharp and randomly oriented with no visible wedge. Similar crack pattern is also visible for the C-EG2 and C-EG3 specimens. However, the cracks are more plastic in appearance indicating cohesion in the surface. The failure is governed by crushing and there is negligible lateral expansion and post yield hardening in the grouts U-EG2 and U-EG3. This behaviour can also be observed in the C-EG2 and C-EG3 grouts, where there is slight bulging and no notable post-yield hardening.

Figure 6. Typical failure patterns cylindrical grout specimens under compression.

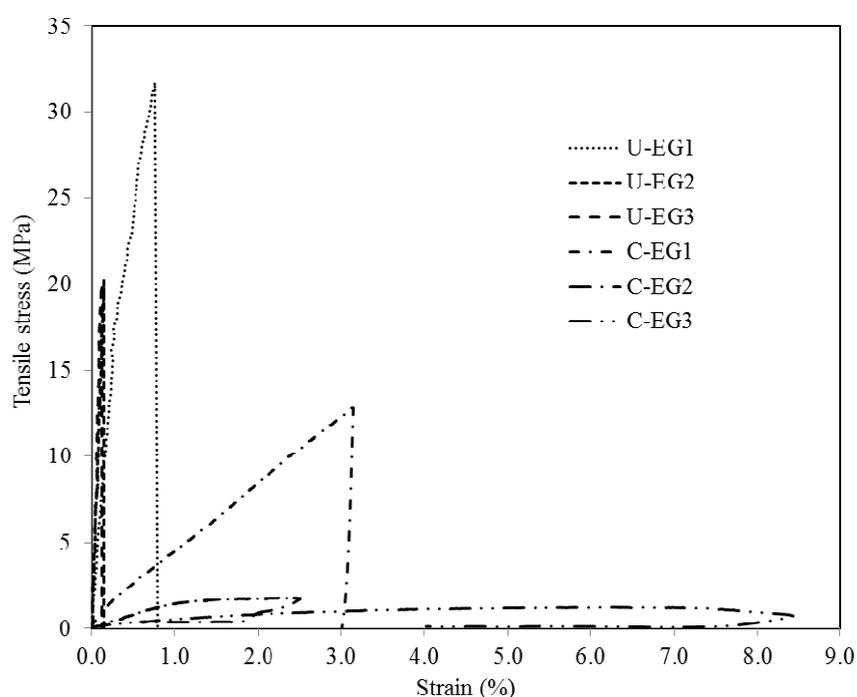
Figure 7. Typical tensile stress-strain behaviour of the grouts.

The comparison of the typical tensile stress-strain behaviour is shown in Figure 7. Unconditioned grout U-EG1 shows relatively prolonged ductile deformation under tensile load exhibiting the highest strength among the grouts. This behaviour may be due to the finer filler in the matrix. Grouts U-EG2 and U-EG3 have moderate strength and the specimens have failed at lower strains than that of grout U-EG1. Conditioned grout C-EG1 shows a linear stress-strain relation exhibiting the highest strength. Grouts C-EG2 and C-EG3 transition to non-linear behaviour almost immediately upon loading, and exhibit very low yield strengths compared to grout C-EG1. The highest failure strain is observed in grout C-EG3. It is to be noted that the tensile strains of the grouts C-EG2 and C-EG3 reverse due to the displacement in the laser reflector tape after the crack formation of the surface of the specimens.

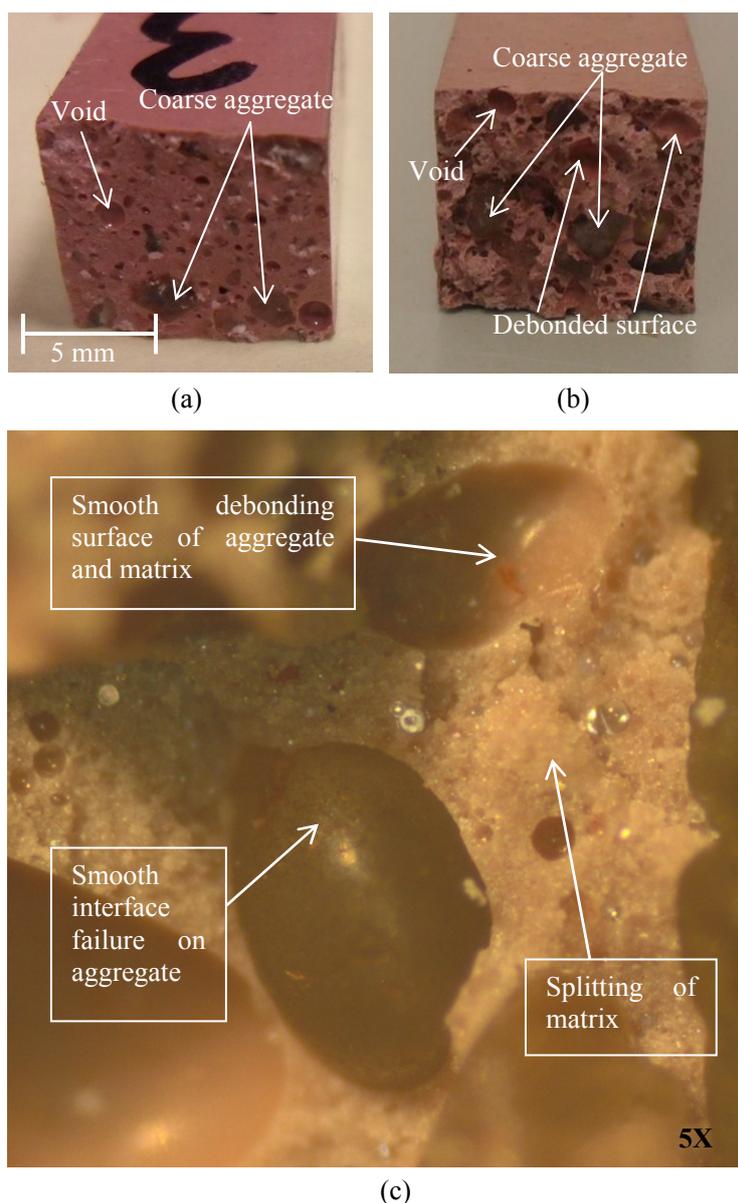
Figure 8. Typical failure surface of tensile specimens of; (a) U-EG3, (b) C-EG3, (c) magnified interface of C-EG3.

Figure 8 shows the typical failure pattern of the tensile specimens. All the unconditioned grouts fail due to splitting, which are perpendicular to the length. The formation of crack in the grouts is sudden and a splitting sound is heard. An observation that can be made is that voids are present in all three cured grouts. The failure surface of grout EG1 has a smooth appearance in both test conditions. The failure surface of unconditioned specimens exhibit smooth texture. Failure surface of the grout U-EG3 is shown in Figure 8(a), which is also representative of U-EG2. It can be seen from the cracked surfaces of the U-EG3 grout that the failure occurs in the matrix through the aggregates. On the other hand, failures in the C-EG3 grout progress slowly compared to grout C-EG1 and are not perfectly perpendicular to the length or straight along the thickness. The failure surfaces of the grout C-EG3 specimens are similar; they appear jagged and the coarse aggregate fillers are visible as shown in Figure 8(b). The magnified view of the failure surface of the conditioned C-EG3 as given

in Figure 8(c) shows that failure occurred in the matrix-aggregate interface unlike the phenomenon in the unconditioned specimens. The interface failure between the resin matrix and the aggregate is due to the effect of hygrothermal conditioning which weakens the interfacial bonding.

The cracked surfaces of both unconditioned grouts EG2 and EG3 show that the failure occurs in the matrix as shown in Figure 8. On the other hand, it can also be seen that debonding of aggregate

and matrix in the conditioned grouts is smooth indicating that interface bonding between aggregate and matrix is weaker than the particle strength of the aggregate. Again, since the matrix itself splits, the resin matrix is weaker than the aggregate particle strength. This behaviour in the conditioned grouts is opposite to the behaviour in unconditioned grouts. Both of these scenarios are described in another study [28]. The failure in the unconditioned grouts is such that the individual aggregate strength is higher than both the resin matrix and the interface bond. The possibility is that the aggregate is strong enough to provide sufficient resistance against failure where the failure occurs thorough the resin matrix and the aggregate, provided the matrix is also stronger than the interfacial bonding energy. In contrast, this situation of conditioned grouts especially grouts with coarse filler align with the argument that the resin matrix, and the matrix-interface bond is weaker than the individual aggregate. From a detailed magnified view of grout EG3 shown in Figure 8(c), it can be seen that aggregates does not split due to tensile force. This implies that hot-wet conditioning reduced the strength of the matrix-grout interface of the grouts.

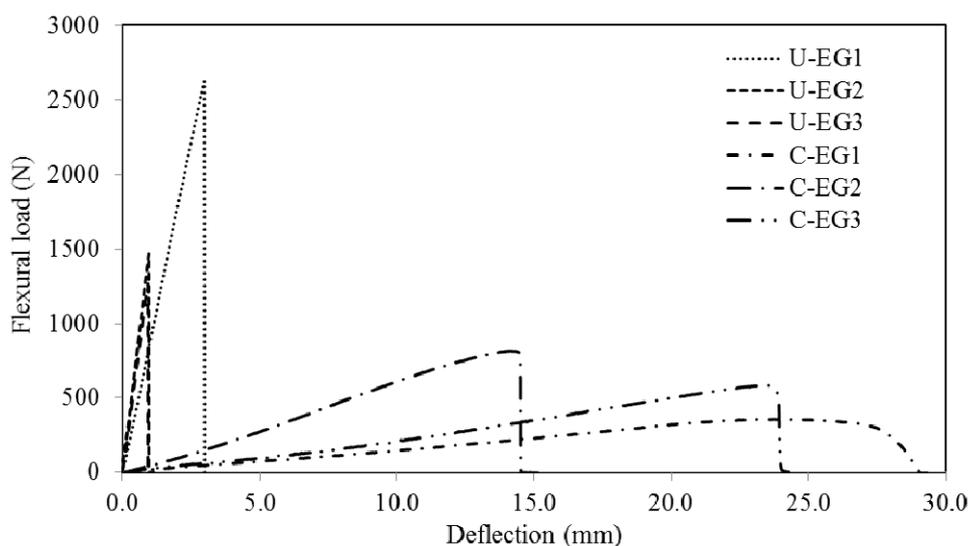
Figure 9 shows a comparison of typical the load-deflection behaviour of the grout specimens in flexure. The unconditioned grouts show linear load-deflection behaviour prior to failure. Grout EG1 has the highest flexural strength with a value of 53 MPa. Grout U-EG3 has strength of 35 MPa which is lower than grout U-EG1 due to the addition of coarse filler. The flexural stiffness of grouts U-EG2 and U-EG3 is about 13 GPa which is higher than that of grout U-EG1. Conditioned grouts C-EG2 and C-EG3 also showed linear load-deflection behaviour prior to failure, whereas grout C-EG1 exhibits a brief plateau before failure. Grout C-EG2 exhibits the highest load and least deflection prior to failure while grout C-EG1 exhibits the lowest load and highest deflection. As shown in Table 3, despite the intermediate tensile strength and elastic modulus, grout C-EG2 has the highest flexural strength and flexural stiffness, at 19 MPa and 0.53 GPa, respectively. Grout C-EG1, which shows the highest tensile strength and elastic modulus, exhibits the lowest flexural strength and flexural stiffness. This suggests that flexural stiffness of the grouts are considerably affected by hygrothermal ageing.

Figure 9. Typical flexural stress-strain behaviour of the grouts.

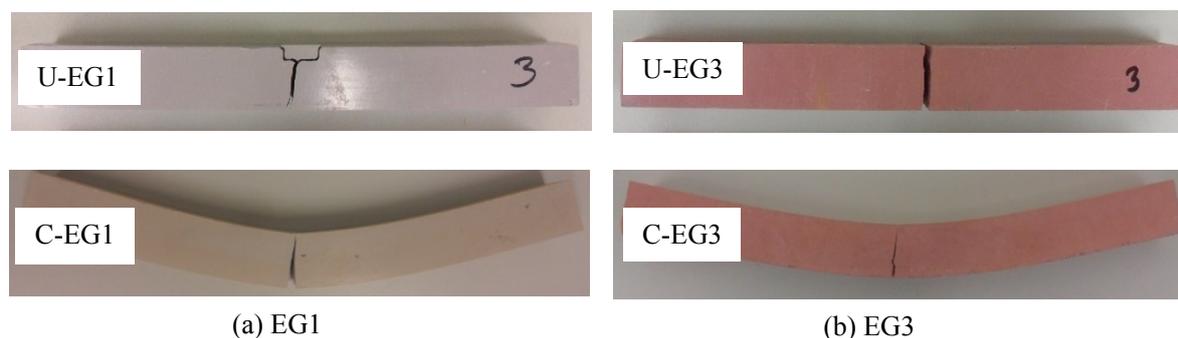
The typical failure patterns of the flexural specimens are shown in Figure 10. All unconditioned specimens fail in a brittle manner. The cracks are almost perpendicular to the longitudinal axis for specimens U-EG2 and U-EG3. However, the cracks deviate from its tension zone alignment when they propagate towards compression zone for grouts U-EG1 and compression wedge is formed. Also, inspection of the cracked surface suggests that the failure of the resin matrix propagates through the aggregates. This behaviour is also comparable to the tensile behaviour discussed earlier. On the other hand, all the conditioned specimens undergo considerable deformation before failure as seen from Figure 10(b). The cracks are perpendicular to the length for all conditioned grouts with the compression wedges not apparent from the failure surfaces. Further inspection of the cracked surface revealed that failure of the resin matrix propagates through the resin matrix, and interface of the resin

and aggregate. This behaviour is comparable to the tensile failure behaviour of the conditioned specimens.

Figure 10. Typical failure pattern of flexural specimens.

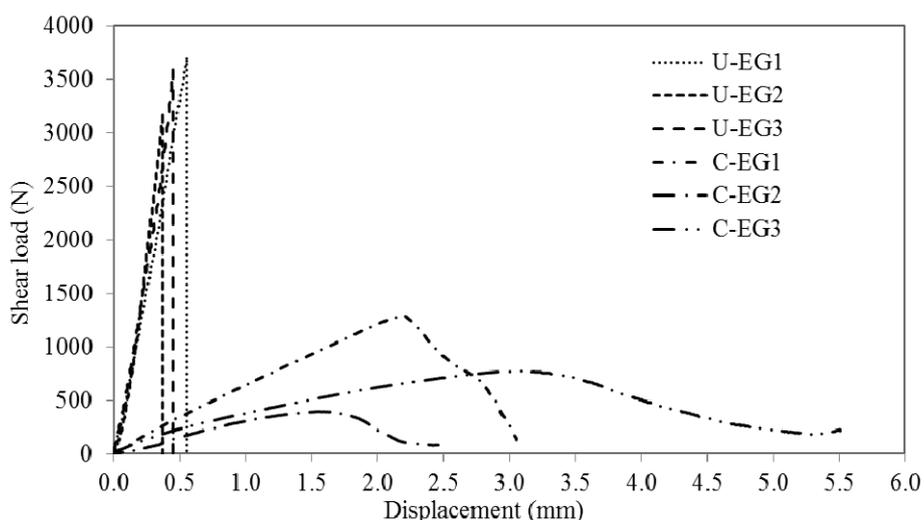
The shear strength of the unconditioned grouts U-EG1, U-EG2 and U-EG3 are 30, 25 and 28 MPa, respectively while the conditioned grouts C-EG1, C-EG2 and C-EG3 are 10 MPa, 3 MPa and 6 MPa, respectively. Hence, the shear strength is affected adversely due to inclusion of filler. Grout C-EG3 exhibits lower shear strength than that of grout C-EG1. Figure 11 shows the relative comparison of load and crosshead displacement of the grouts under shear loading. Grouts U-EG1, U-EG2 and U-EG3 exhibit linear load-displacement behaviour before distinct reduction in load during failure, which is also applicable for C-EG1. However, grouts C-EG2 and C-EG3 show relatively smooth transition in the load-displacement plot during failure.

Figure 11. Typical shear load-deflection behaviour.

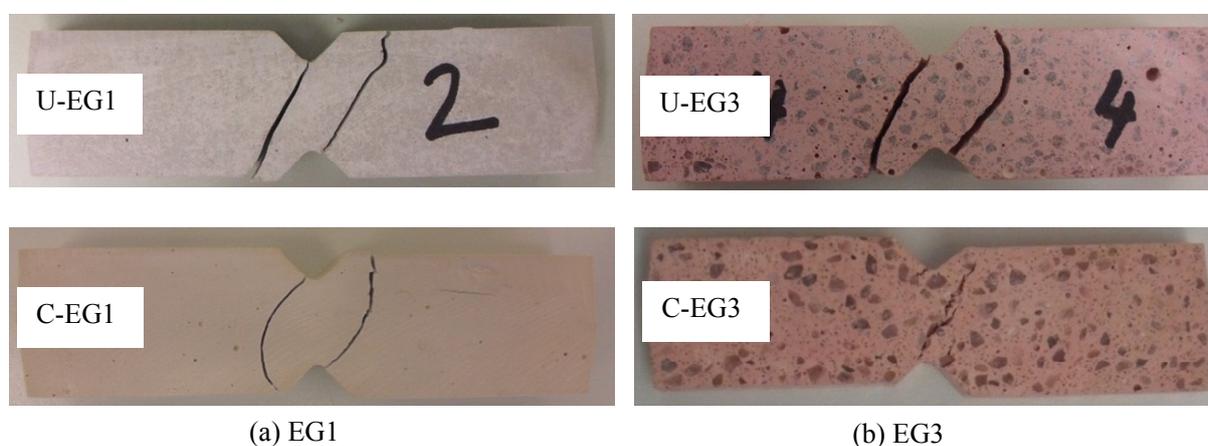
The failure occurs suddenly after the peak load with no prior warning in all the unconditioned grouts. However, the conditioned specimens undergo considerable deformation prior to failure. The failure is made up of two diagonal cracks and a failure wedge in-between the cracks in the unconditioned grouts as shown in Figure 12. Typically, formation of a shear wedge is observed from one crack running from bottom of the top notch towards the bottom plane surface and the second crack running almost parallel from the top of the bottom notch diagonally towards the top plane surface. Hence, it is evident that the failure in the unconditioned grouts is a combination of shear and tension which was also reported in Iosipescu coupon specimen made of graphite [18]. On the other hand, the conditioned grouts failed gradually after the peak load. The angle of the shear cracks was between 30 and 45°. The failure of the conditioned grout C-EG1 is composed of two diagonal cracks and a failure wedge in-between the cracks is similar to U-EG1. Whereas, the grouts C-EG2 and C-EG3 exhibit one large crack with smaller parallel cracks near the notches at the specimen edges.

Figure 12. Typical failure pattern of shear specimens.
