Research article

Characterization of the Kringelmomyra peatland: geotechnical, hydrogeological, and ecological aspects

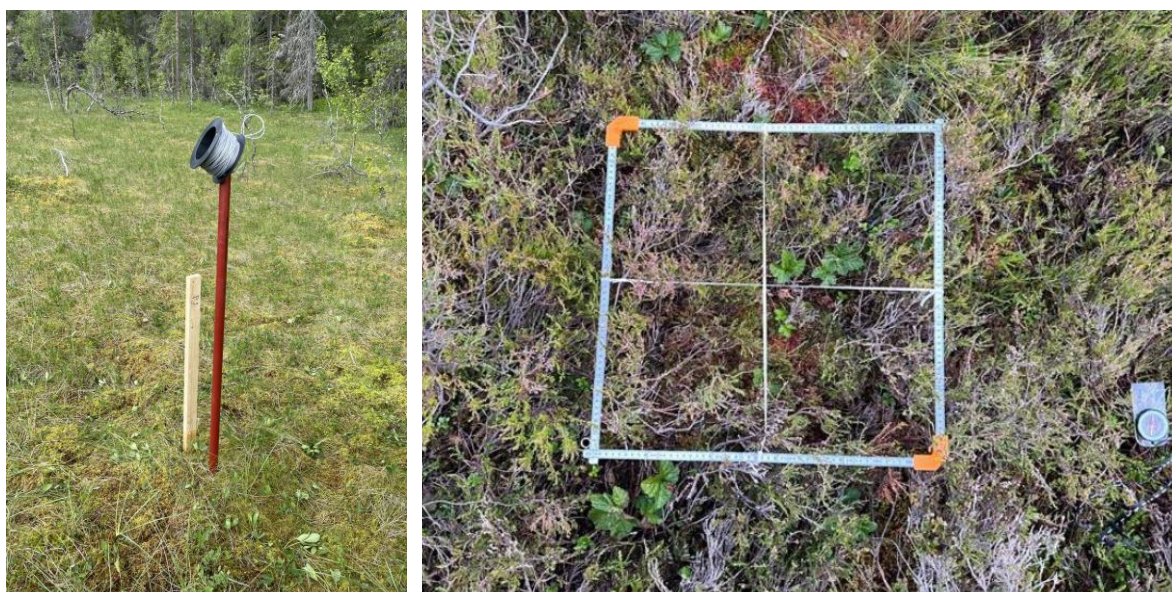
Figure 4. Examples of (a) pore pressure sensor installed at Kringelmomyra (photo: NGI) and (b) vegetation plots for vegetation monitoring (photo: Gunnar Kristiansen).

Pore pressure sensors (see Figure 4a) have been installed since the construction of the road started (July 2022), and measurements are taken twice per day to monitor the changes in the groundwater level. These sensors were installed by pushing them manually into the peat, and they were located based on the dominant direction of water flow (see Section 5), terrain, and design of the road. The road design incorporates four 2-mm double-textured geotextile membranes installed transversely across the road body (indicated by orange lines in Figure 3d). These membranes are intended to prevent water movement within the granular road fill and to reduce drainage of the underlying peatland. The pore pressure sensors were located near these geotextile membranes and in transects (T1–T4, as in Figure 3d) perpendicular to the road alignment, allowing monitoring of the groundwater level in one dimension.

Vegetation monitoring has been established at the site to evaluate the effect of the road construction on the plant community of the remaining peatland at Kringelmomyra. Surveys have been conducted at the site in 2022 and 2024, with a third registration scheduled for 2026. At the site, all plant species, including bryophytes, were recorded within plots of 50 × 50 cm (Figure 4b). The cover of all species was estimated visually. In 2024, the frequency of all species was also recorded as present or absent within 16 subplots in each plot. In total, 11 plots were established close to the pore pressure sensors, five to the west of the road and six to the east.

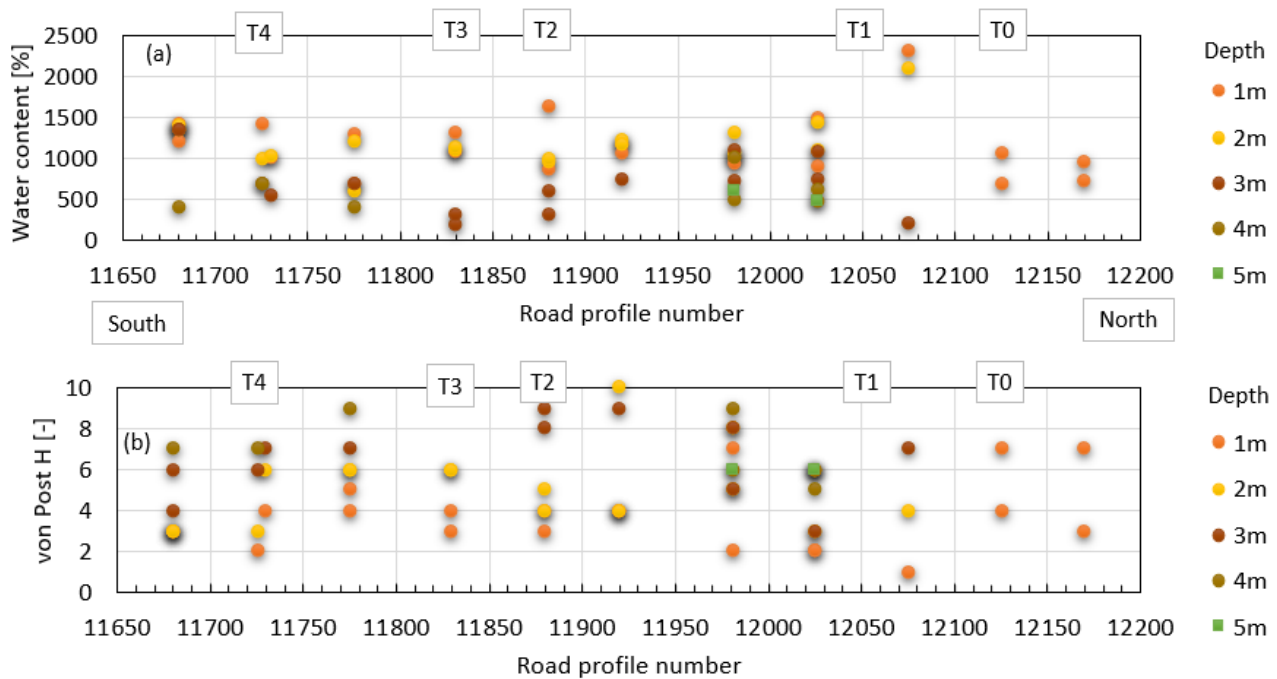
Figure 8. (a) Water content and (b) degree of decomposition (H) following von Post classification along the centerline of the road, before construction.

- **Upper peat layer:** the top 1–2 m of the peatland. The upper peat layer has limited peat decomposition (von Post values H [22] ranging between 2 and 4), which means that it has a high fiber content and relatively high strength, as the fiber and roots bind the material together. The geotechnical water content is high and typically varies between 700 and > 2000% (ratio of the weight of water divided by the weight of solids). See Figure 8.

- **Lower peat layer:** This peat is between 2 and 5 m below the surface. The lower peat layer is more decomposed ($H = 6\text{--}9$), and roots and fibers have broken down. This means that the peat material varies from having a very indistinct plan structure to a material where it is hard to recognize plant structures. This results in the strength of the peat being lower. The water content in the lower part is less than in the upper part, with typical values ranging between 400 and 700%. See Figure 8.

Figure 8 shows the water content and degree of decomposition following von Post classification of peat samples taken along the centerline of the road, before construction. The high variability in the water content makes it difficult to establish correlations between water content and the degree of decomposition. However, one can expect that peat with a higher degree of decomposition (higher H value) generally has higher water content. This is because the amorphous and colloidal nature of more decomposed peat allows it to hold more water. The water content values, degree of decomposition, and peat thickness for Kringelmomyra agree with typical values for peatlands in Norway, according to a database published by [11].

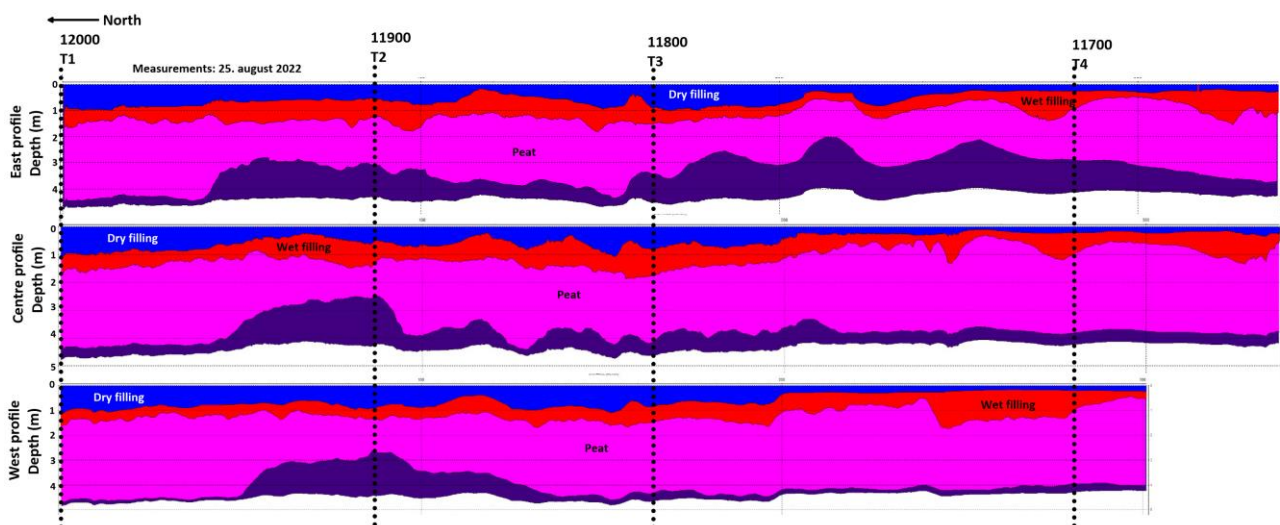
Figure 9. Fill and peatland thickness along the road line mapped in August 2022 with GPR. Transects (T1–T4) of pore pressure sensors indicated. The lowermost unit indicates the clay unit. The figure is updated from [24].

Figure 9 shows the results from GPR mapping for the peat thickness and preloading filling, after the latter was established. The GPR survey was successful in identifying the thickness of the filling. It can be seen that at locations T1, T2, and T3, the fill is approximately the same thickness (approximately 1.5 m), but the peat thickness at T2 and T3 is smaller (approximately 2.5–3 m). At T4, the fill is thinner (approximately 1 m) than in other areas, while the peatland layer reaches approximately 4 m depth. The filling and peat thickness are important aspects when monitoring the settlements in the area, since current observations [23] indicate that the greatest vertical deformations occur in the areas where the peatland is thickest (i.e., at T4 and T1), and that the settlement differences between T4 and T1 may be due to the lower thickness of the filling placed at T4. Further analysis of the settlements data is included in [23]; since this project is ongoing, it will be presented in another parallel publication.

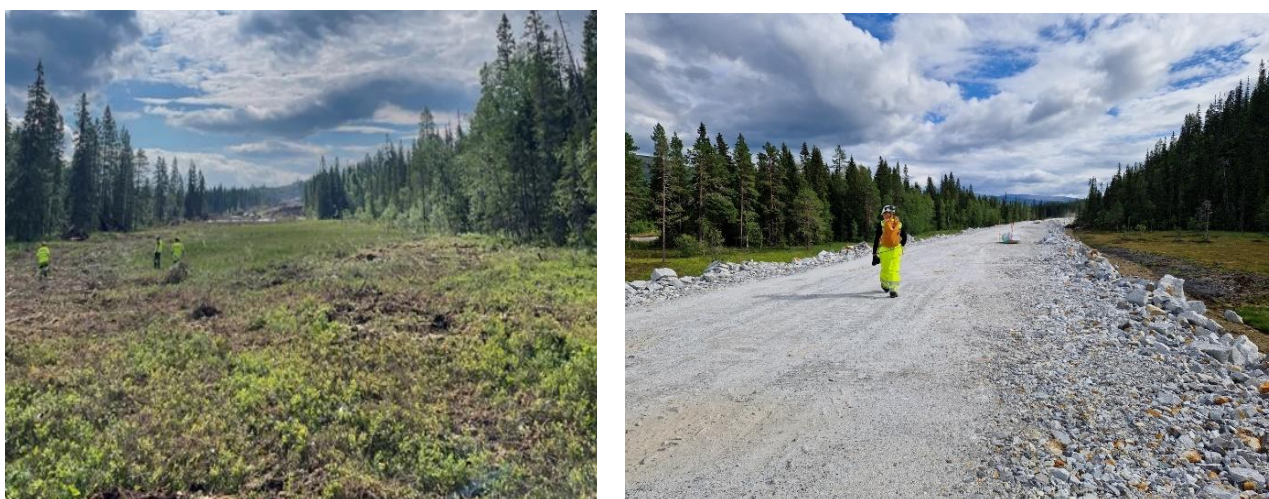
Figure 12. View of Kringelmomyra from the north to the south, (left) before (2022; photo: NGI) and (right) after (2024; photo: NINA) the construction of the road embankment.

Kringelmomyra is a typical Norwegian peatland, in which the planned road placement is directly on the peatland surface (see Figure 12). One of the initial objectives of the monitoring program is to identify potential changes in the hydrogeology and biodiversity of the remaining peatland as a result of the compression of peat masses for the construction of the road. So far, the results show little impact on hydrogeology in Kringelmomyra from the establishment of preloading and preliminary work [23], as presented in Figure 13 for Transect T4. In that location, it is observed that the groundwater level remains above the terrain and appears to be consistent throughout the same yearly period, despite variations in the precipitation regime.

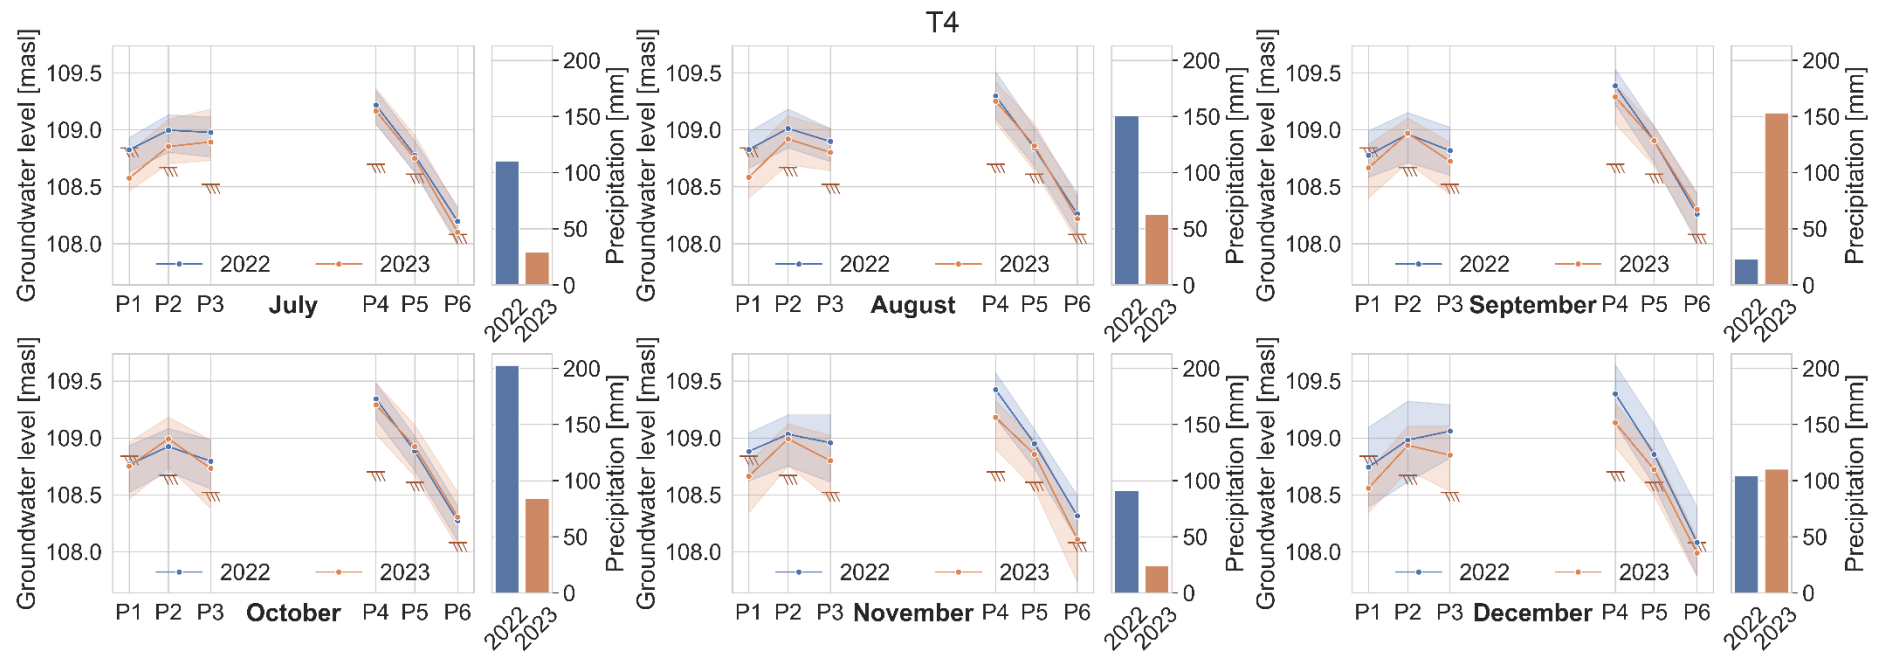
Figure 13. Comparison of water level (shown with line plots) and precipitation (shown with bar plots) in the period July–December for Transect T4 for 2022 (data in blue) vs 2023 (data in orange). Terrain level is indicated with m . Taken from [23].

With the construction of a road over the peatland surface as a floating road, the goal is to maintain the water level in the peatland to preserve the carbon stored in the soil. The carbon fluxes at the site have not been monitored, and how successful the method is in keeping the existing carbon stock is unknown. Rather, this study has focused on the technical solution and practical execution for the construction of a road at Kringelmomyra as presented in [27]. Table 1 summarizes some important learning points taken from [27]. These are aspects focusing on the geotechnical properties of the peat at the time of construction and the expected performance of the road being built. Furthermore, whether the remaining parts of Kringelmomyra will be affected by the construction work is still unknown, as it is too early to do a thorough analysis of hydrogeological and ecological aspects. A longer monitoring period will provide data on how the construction work has affected the water level table and the vegetation at the site.
