Research article

Investigation of thermal fatigue behavior of aluminum 4032 alloy under cyclic thermal loading: An experimental study

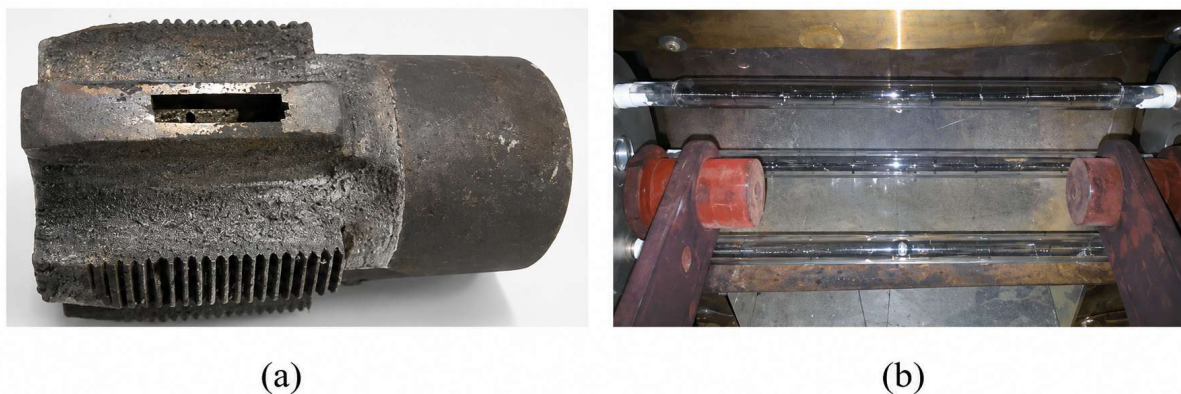
Figure 1. (a) Heating tab and (b) heating filaments.

A thermal fatigue experimental setup was designed and fabricated for thermal fatigue analysis of different alloys, i.e., aluminum, copper, and different low-melting materials. For thermal fatigue purposes, cyclic heating and cooling were applied to the wedge-shaped specimen. A constant-temperature milled steel tab was provided for heating purposes. The wedge-shaped specimen was in contact with a drilled hole on the tab. Four electric rod filaments were attached around the tab. These electric filaments were controlled with a thermocouple controller to maintain the required constant temperature. Heat transfer to the specimen was achieved through direct contact with the heated steel tab. The heating system was controlled using a thermocouple-based feedback mechanism to maintain the desired temperature at the heating tab. Consistent mechanical contact between the specimen and the heating surface was ensured using a spring-loaded mechanism throughout all experiments. This arrangement allowed limited freedom for thermal expansion while maintaining stable contact. No external mechanical load was applied; however, minor contact forces and frictional interactions may have existed at the interface. The system was operated under steady-state conditions to ensure consistent thermal input during the experimentation. Temperature was measured using a K-type thermocouple positioned near the specimen tip. This provides local temperature history for cycle control. For temperature measurement, a K-type thermocouple (OMEGA Eng.) with an accuracy of ± 0.5 °C was used. Prior to experimentation, thermocouples were calibrated using a two-point calibration method: an ice water bath at 0 °C and controlled boiling water at 100 °C under local atmospheric pressure. The maximum deviation observed after calibration was within ± 0.3 °C. Each rod consumed 1000 W and generated an electric flux, heating the tap, as shown in Figure 1.

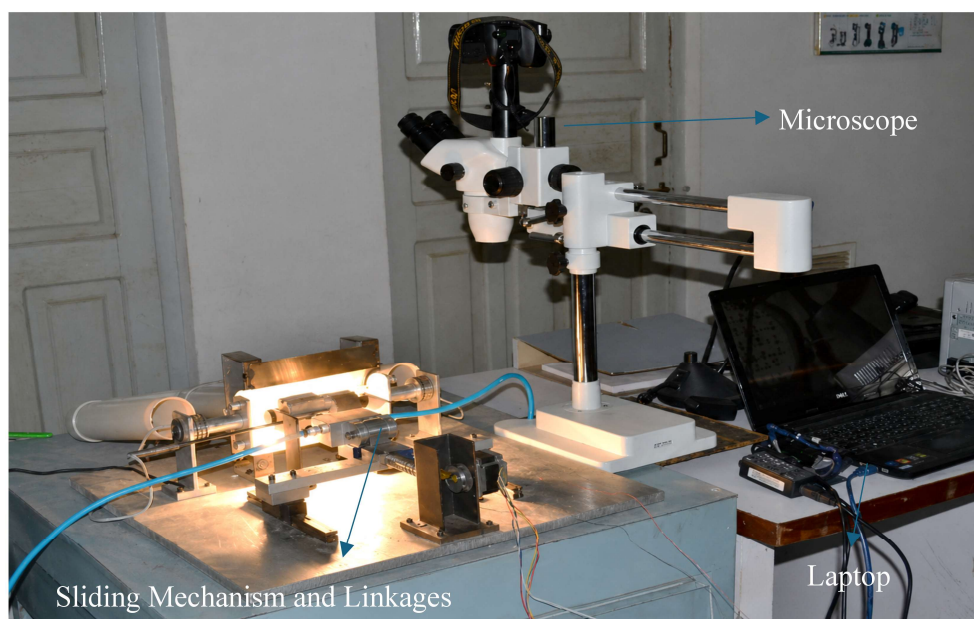
Figure 2. Experimental setup.

High temperature and electricity can damage the sliding bars, electric connectors, and protection plate. The compressed air-cooling system was used primarily for thermal protection of the system components and stabilization of the experimental environment. Airflow conditions were kept constant during all experiment runs. To protect all components, a blower with distribution pipes was designed and installed on the experimental rig. The blower cooled down the setup to the minimum possible temperature. The specimen, together with its holder, can slide on two sliding bars in a “to-and-fro motion” for specified cooling and heating, in which the edge of the specimen is continuously attached or detached from the tab for a specified time. A stepper motor was used for sliding the specimen holder using linkages and rods. A spring was used to properly attach the specimen to the tab so that heat was transferred through conduction. To investigate crack initiation and propagation, optical microscopy (Optika Microscope Italy) was used. The Stereo Zoom Microscope (SZM) is a high-performance microscope with a continuous zoom system of 0.67–4.5× and widefield high-point 22 mm eyepieces. An Arduino Uno R3 was used, and a complete electronic circuit was developed for controlling stepper motors. The electric circuit included Arduino UNO R3, H-Bridge L298, stepper motor, push button, Max 6675, K-type thermocouple, and a power supply. The experimental setup is shown in Figure 2.

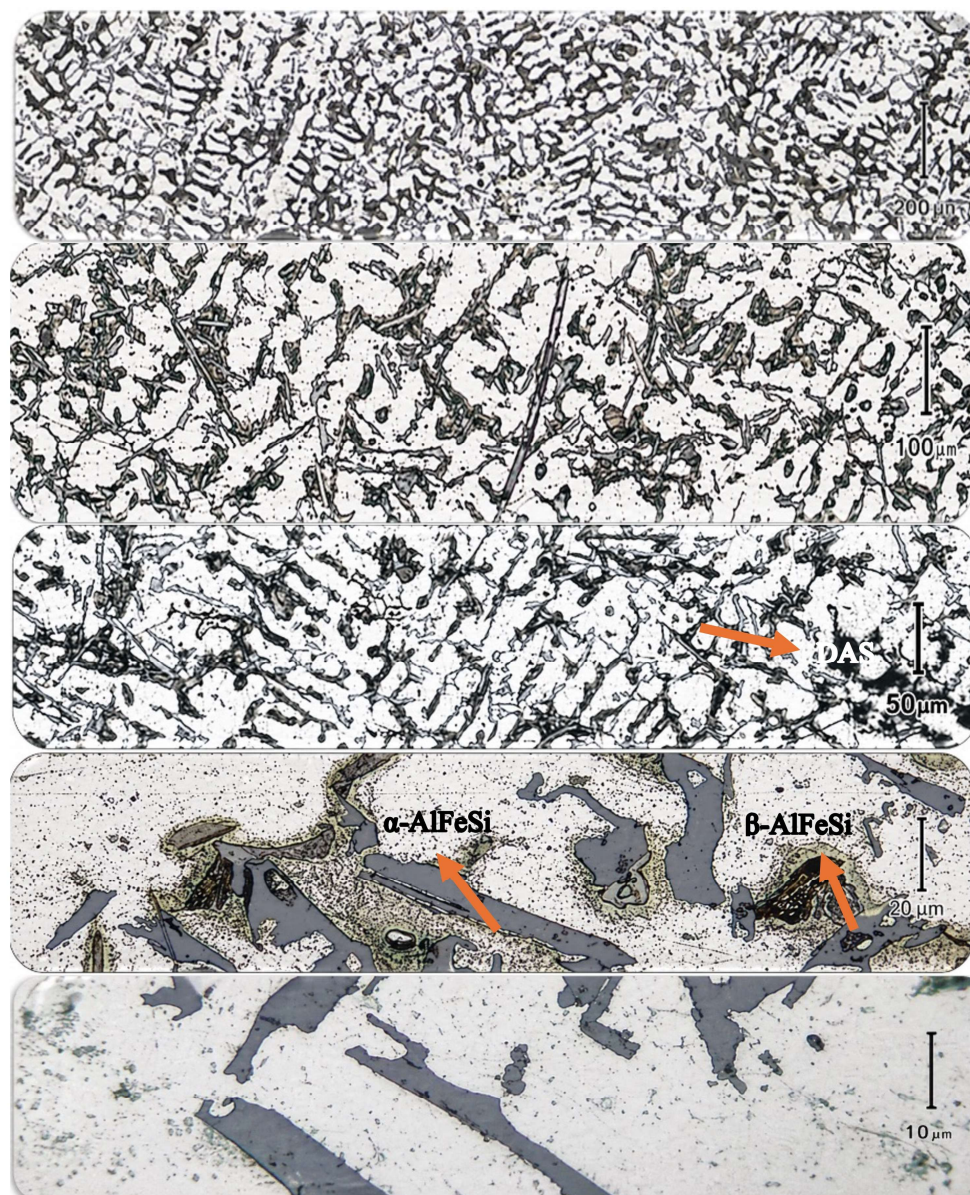
Figure 4. Microstructure of Keller's etchant at different magnifications.

The OLYMPUS BX51 metallurgical microscope was used to investigate the grain boundaries of the cast aluminum. The dendritic microstructure of casted Al4032 is shown in Figure 4.

Figure 4 shows DAS at different magnifications for the as-cast aluminum. As per the ASTM standard book *Metallography and Microscopy, Volume 9* [34], as-cast aluminum 4xxx series enriched with Si exhibits four morphologies, namely Si, Al₂Cu, β -AlFeSi, and α -Al (FeMnSi), without heat treatment. Weck's etchants are mostly used to investigate hypereutectic as-cast aluminum, eutectic α -Al, and Si, and are viewed with polarized light. Weck's etchant is easy to use and provides good results for cast aluminum.

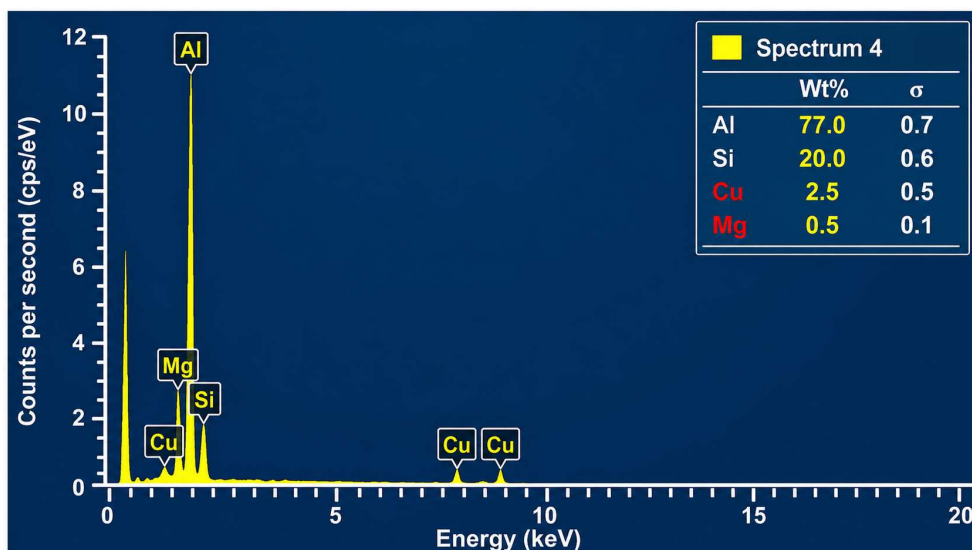
Figure 7. Chemical composition of Al4032.

Al4032 is used in pistons due to its enrichment with silicon. It has low thermal expansion while working at high temperatures. The chemical composition of the specimens tested by SEM is shown in Figure 7.

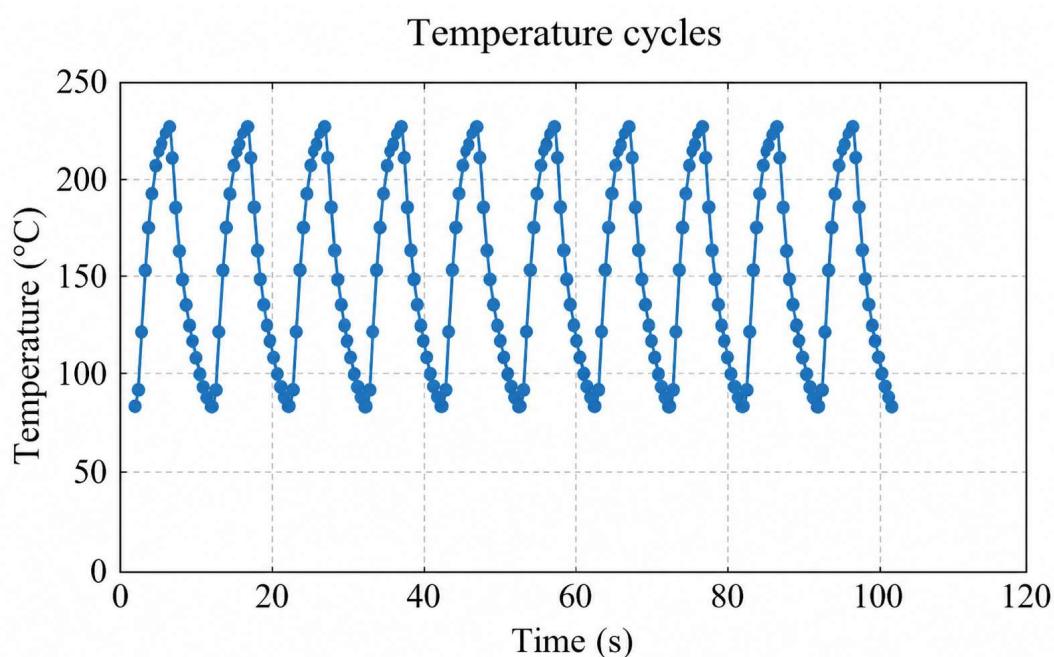
Figure 9. Ten temperature cycles.

Experiments were carried out on a fabricated thermal fatigue rig. Two cooling systems were installed in the experimental rig. One cooling system was for specimen's internal cooling, where water was used for cooling at a flow rate of $100 \text{ mm}^3/\text{s}$, and water temperature was kept at $25 \text{ }^\circ\text{C}$. Water flow of water could be controlled by a bypass valve that slightly changes the flow rate. The second cooling system was installed on the rig cooling back plate of the tab. This tab plate was cooled by compressed air; a blower was used to supply compressed air, and pipes were used to direct this air toward the tab plate and electric connectors. The tab temperature was controlled by a temperature controller. A thermocouple was connected to the temperature controller, which senses the tab temperature. The cutoff temperature was set by the temperature controller. Different temperatures were set (e.g., 400 , 500 , and $600 \text{ }^\circ\text{C}$). The servo motor moved the specimen back and forth, which cyclically heated and cooled the specimen tip, while the back of the specimen remained at constant temperature. To obtain the temperature of the specimen tip, a k-type thermocouple was mounted 1 mm from the tip. For mounting the thermocouple, a 1 mm hole was drilled in the specimen. This thermocouple continuously provided readings. By increasing heating and cooling time, maximum and minimum temperatures were also increased, but further increases in time provided a constant temperature curve. To increase specimen temperature, the tab temperature could be increased; however, there were some limitations in the design of the rig for increasing the temperature. At the same time, by decreasing the temperature of the cooling cycle, the temperature of the water must be kept low. The temperature of the specimen reaches a steady-state condition after a few hundred cycles. The thermal cycling waveform consists of alternating heating and cooling phases, each lasting 10 s , resulting in a periodic thermal cycle. The specimen tip temperature varied between 75 and $270 \text{ }^\circ\text{C}$. No isothermal holding stage was applied, and heating and cooling rates were governed by the thermal response of the system under these controlled time intervals. The experimental temperature cycle is shown in Figure 9.

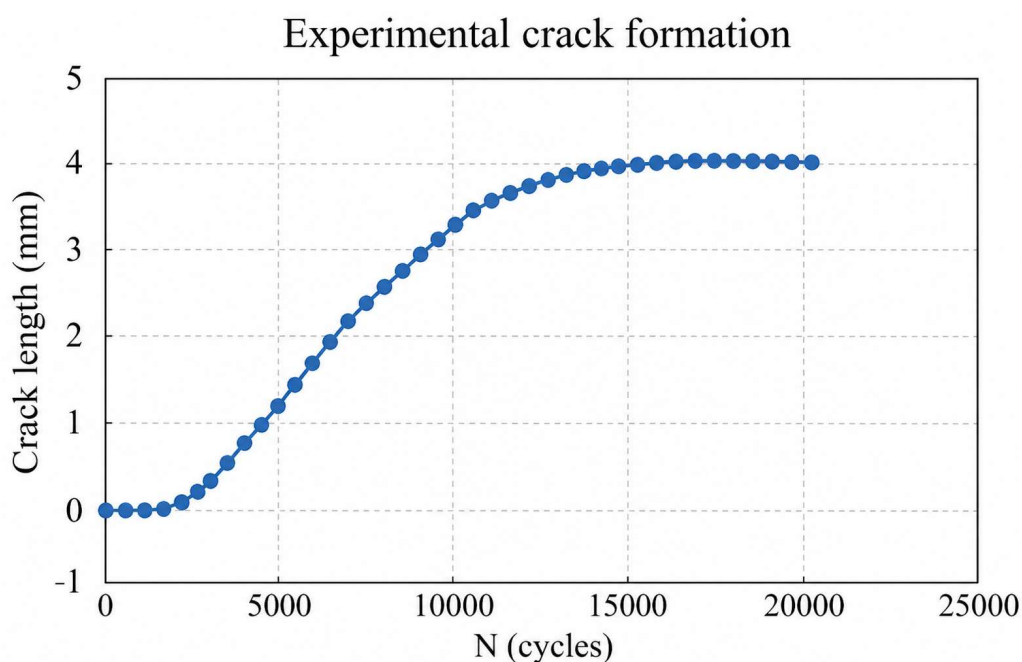
Figure 10. Crack length vs. cycles.

The temperature range is consistent with subsurface thermal conditions in piston components subjected to internal cooling, where thermal gradients are more critical than peak surface temperatures in governing fatigue damage. This graph shows steady-state conditions of the specimen temperature. One edge of the specimen, being wedge-shaped, cyclically bears thermal fatigue in the range of 75–270 °C. Heating and cooling times were kept to 10 s. The tip of the specimen was tested after every 500 cycles using the Optika Microscope Italy. Cracks could only be seen when they reached up to 300 μm . Additionally, an oxide layer can also form, which affects the detection of cracks under the microscope [25]. Cracks can be observed during initiation, propagation, and saturation. Cracks in Al4032 were observed after approximately 3000 cycles under the tested conditions. During the propagation stage (the main stage) crack depth is sharply increased. In Al4032, crack growth was observed to stabilize after approximately 15,000 cycles. Afterward, crack propagation ended, and crack length remained constant with increasing cycles. This stage is called crack saturation, as shown in Figure 10.

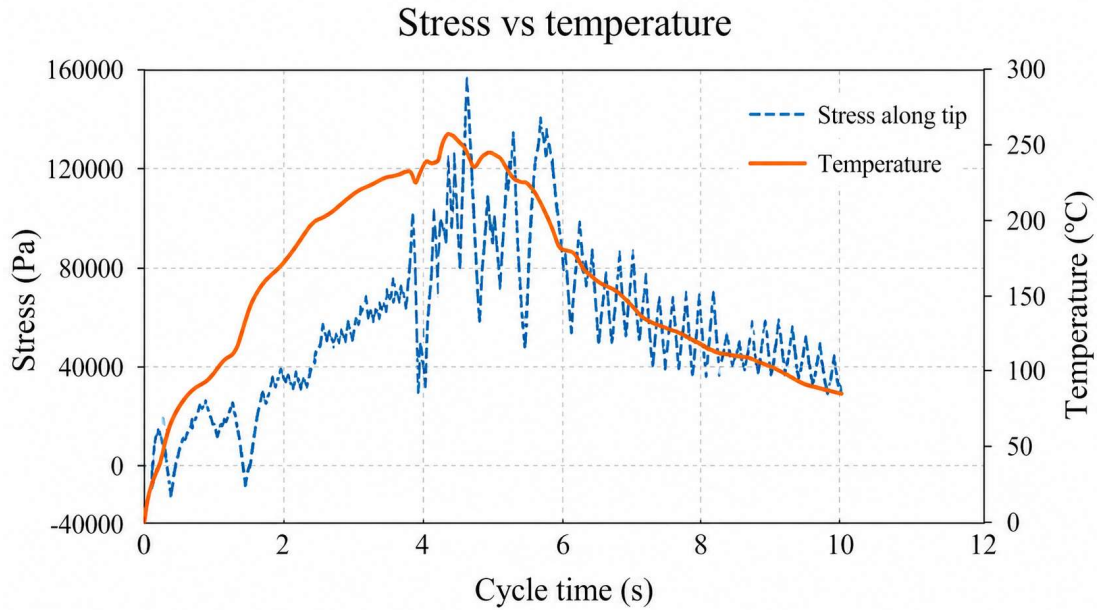
Figure 11. Stress vs. temperature.

The specimen was designed to minimize external mechanical constraints; however, minor contact and fluid-induced effects may be present. Under the applied cyclic heating and cooling conditions, thermal stresses are expected to be the dominant contributors to crack initiation and propagation. If a graph is drawn between stress along tips, cycle time, and temperature, the stress profile follows the temperature profile, as shown in Figure 11.

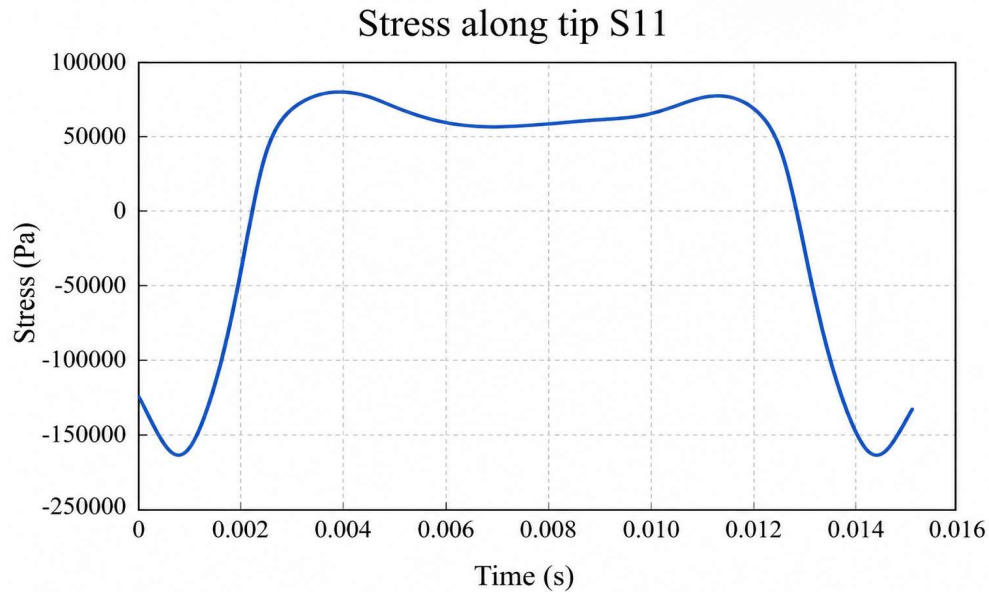
Figure 13. Stress along the specimen tip.

Water cooling stresses were highest in two portions, from 3.3533 to 5.3 mm from the corner on both sides of the specimen. The peak stress along the tip was 76.4 kPa, and in the center, the stress was 60 kPa. Crack initiated in the regions of maximum stress. Figure 13 shows the stress at the tip in the S11 direction, clearly showing that stress was lower in the center than at some distance from the sides.

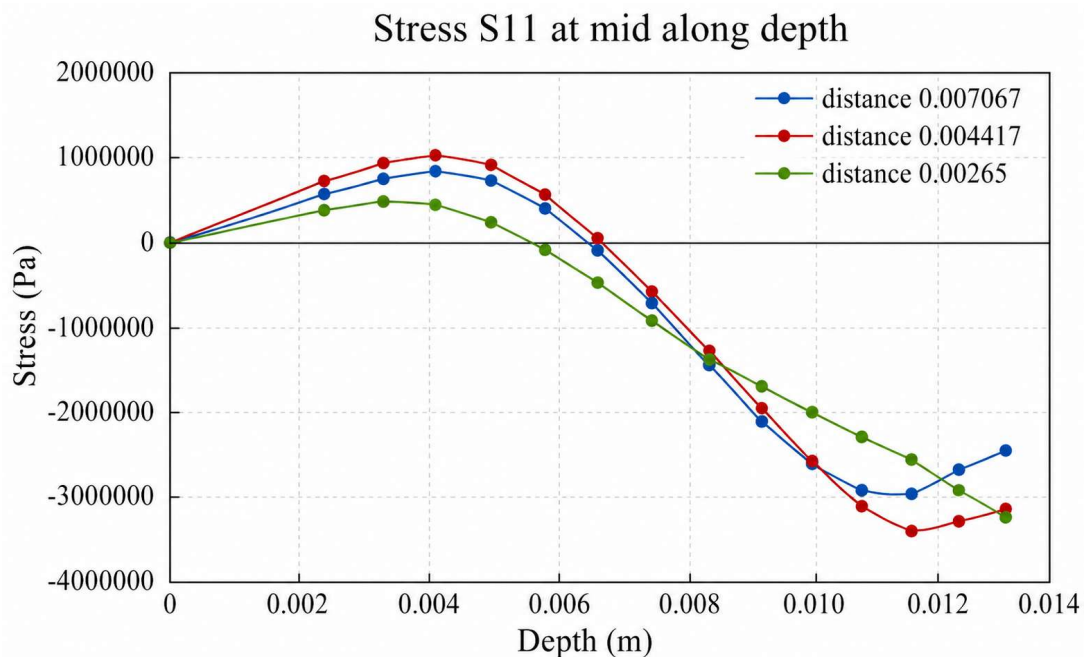
Figure 14. Stress in depth.

Stress at 4.4 mm from the tip remained constant in depth for 4.1 mm; after that, stress reduced. This means that the crack propagated only approximately 4.1 mm. Figure 14 shows that the stress increased along depth at approximately 4.12187 mm at a middle path depth of approximately 7.067 mm. After approximately 6.54501 mm, the stress was compressive; as such, the crack could not propagate further.

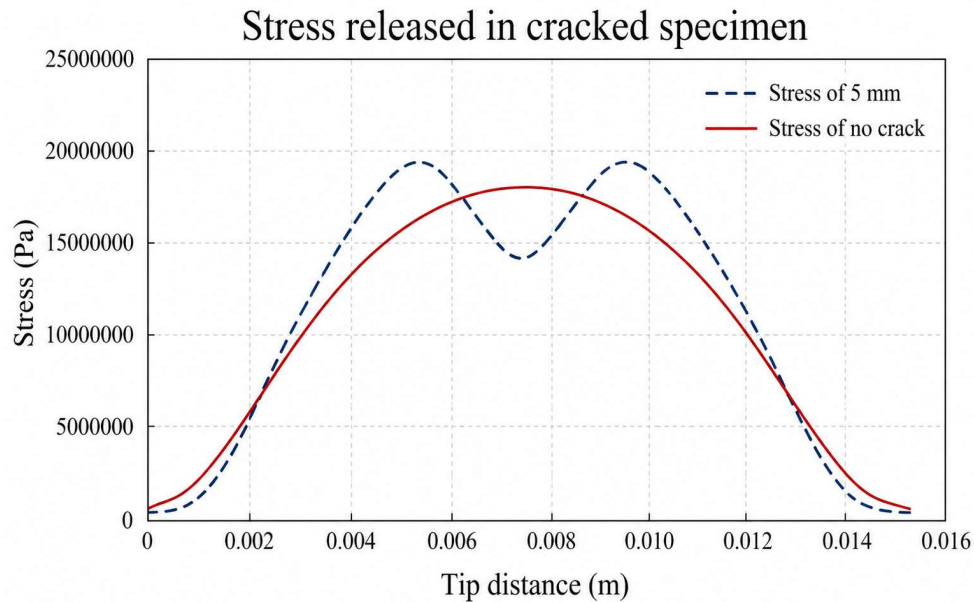
Figure 15. Stress releases in cracked specimens.

Figure 15 shows that the stress along the tip was highest in the area in front of the cooling path and lowest or zero at the corner. However, when any crack initiated at the maximum stress area, it released stress at that zone.

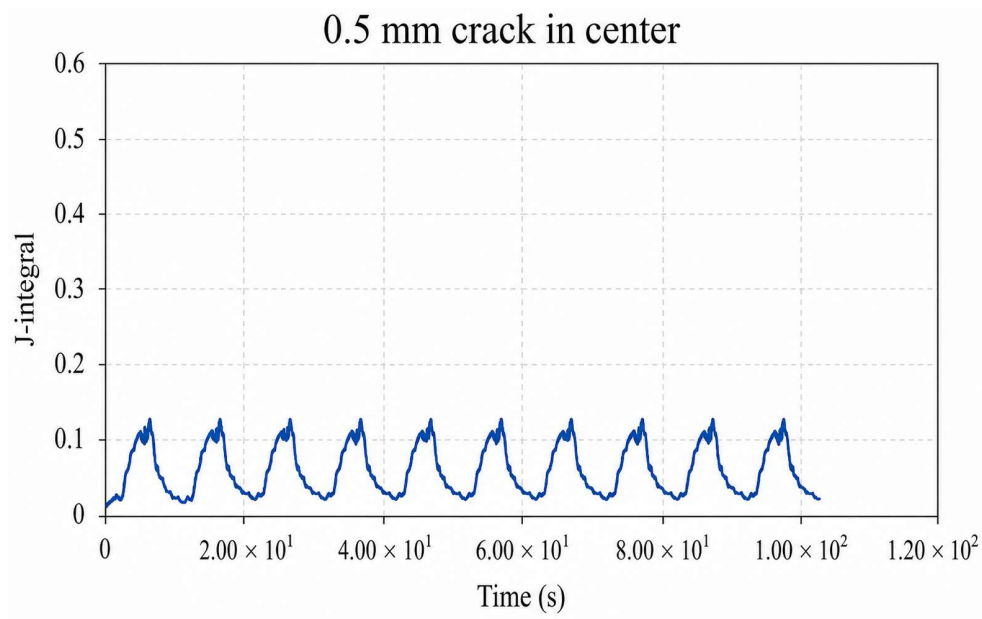
Figure 16. Curve between J-integral and time.

As the cracks propagate, stress release increases. When the stress value becomes very small at the crack tip, the crack stops propagating. Cracks release stress, and the energy release rate is directly proportional to the crack length. As the crack length increases, the value of J-integral also increases. Figure 16 shows the J-integral value at different crack lengths; the J-integral increased at 4 mm crack length; afterward, if crack length increased, J-integral decreased. This means that the crack can only be propagated to the length of 4 mm.

The J-integral represents the energy release rate associated with crack propagation; this value was evaluated to quantify the fracture behavior of the material under thermal fatigue loading. In the present study, the J-integral was estimated based on the relationship between crack length, stress distribution, and strain energy release within the specimen. The variation of J-integral with crack length was determined using the experimentally obtained stress profile and crack measurements, assuming a linear elastic fracture behavior in the crack propagation behavior. The J-integral was considered proportional to energy release and was evaluated as a crack length function using the corresponding stress-field data obtained along the specimen tip.

In the present study, the increase in J-integral with crack length up to approximately 4 mm indicates an increasing driving force during the early propagation stage. Beyond this point, the observed decrease in J-integral suggests a reduction in the effective driving force; however, this alone does not imply crack arrest. The stabilization of crack growth rate observed experimentally is more appropriately attributed to a combination of factors, including thermal stress intensity due to stress redistribution, localized plastic deformation at the crack tip, crack interaction effects, and possible crack closure during cyclic thermal loading. Additionally, thermal fatigue conditions may introduce oxidation and microstructural degradation at the crack tip, which can further influence crack growth resistance. Therefore, the observed limitation in crack propagation is interpreted as a result of evolving balance between driving force and resistance under cyclic thermal loading, rather than a strict geometrical limit imposed by crack length alone.

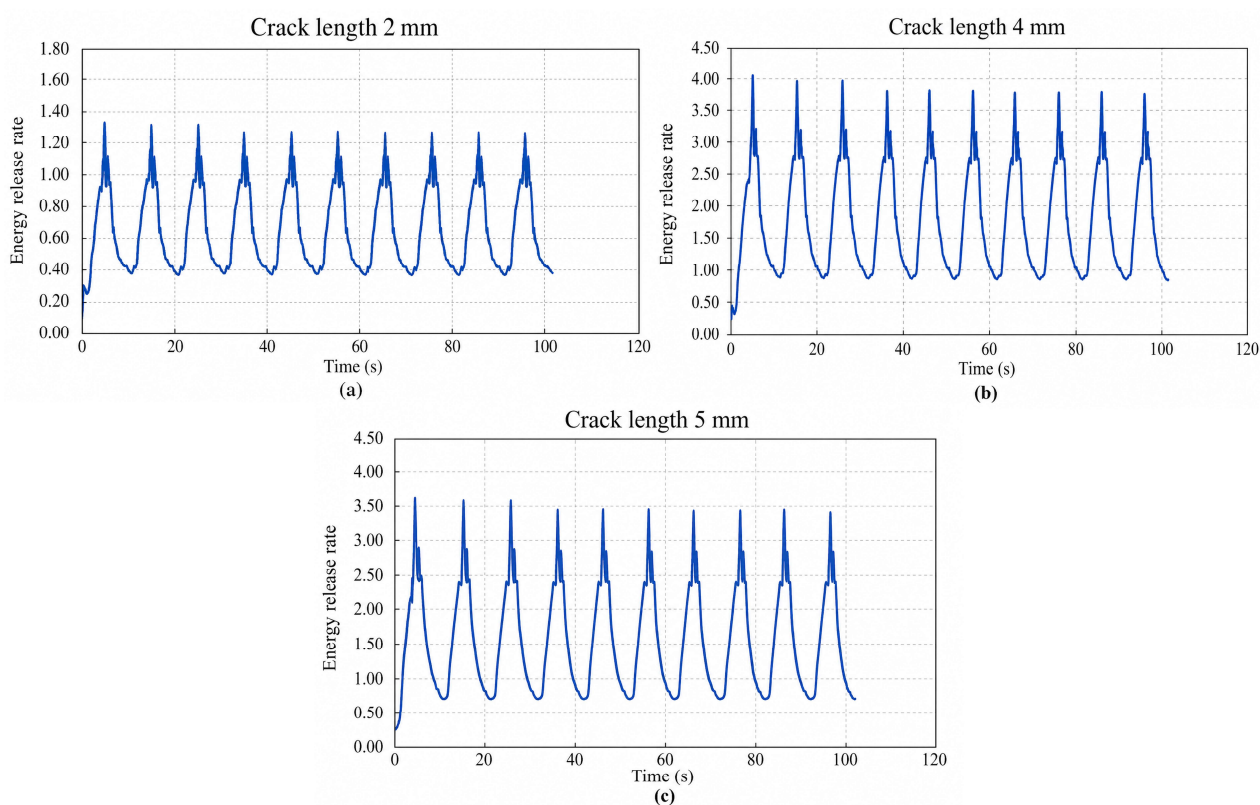
Figure 17. Crack from side 4.4 mm: (a) crack length 2 mm; (b) 4 mm; and (c) 5 mm.

Figure 17 shows the relationship between energy release rate and hundred cycle time. As the crack length increases to 4 mm, the energy release rate or J-integral value increases up to almost 4.00. When crack length increases from 4 to 5 mm, energy release rate decreases to 3.5.
