AIMS Geosciences, 2 (2): 99-115 DOI: 10.3934/geosci.2016.2.99 Received date 15 December 2015 Accepted date 23 May 2016 Published date 26 May 2016

Research article

ERT-based Investigation of a Sinkhole in Greene County, Missouri

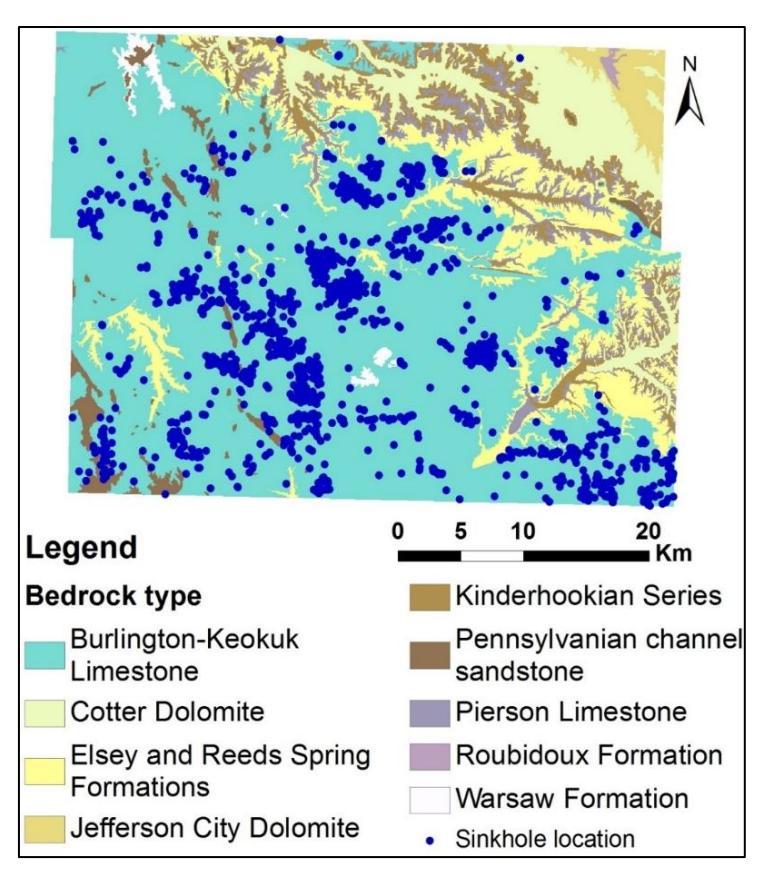
Figure 2: Geological map of Greene County, Missouri (Esri data source: Missouri Geological Survey GEOSTRAT system, Sept 2015).

The Mississippian age Burlington-Keokuk Limestone is the dominant bedrock exposed in the study area (Figure 2). In this bedrock, layers of limestone are interbedded with thin layers of chert and the presence of chert nodules within limestone layers.

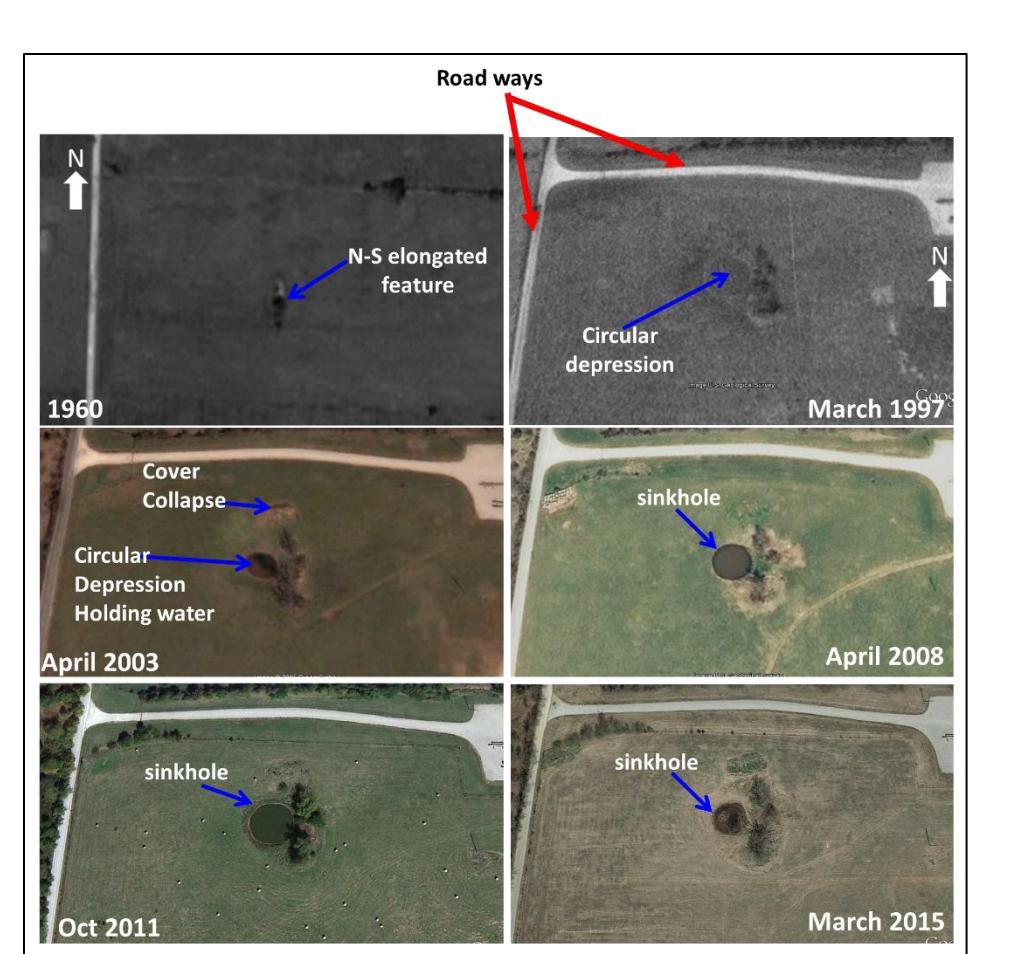
Figure 3: Historical Aerial photos of Sinkhole_1; the paved road ways can give an idea about the scale of the images.

An aerial photograph from 1960 and a series of historical google earth images (Figure 3) were analyzed to reveal the evolution of Sinkhole_1, anthropogenic factors and land use changes. The 1960 aerial photo on the top left of figure 3 shows a north-south elongated feature which is a row of trees along a natural north-south surface drainage pathway in the middle of a farmer's field. To the north of the row of trees, there is a small surface depression. This suggests that Sinkhole_1 developed at this location originally as a result of the localized ponding of surface water immediately to the north of the zone of dense vegetation. The ponded water and piped fine-grained sediment percolated into the subsurface through the soil and underlying pervasively fractured limestone. The piping of soil lead to surface subsidence and the enlargement of the sinkhole over time.

The second image, a Google Earth® image from March 1997, shows a well-defined circular depression, immediately west of the row of trees imaged in the 1960 photograph. The circular depression is the surface expression of the Sinkhole_1 in 1997. The sinkhole appears to have migrated to the west as a result of the broadening of the surface expression of the original area of subsidence. The observation that the zone subsidence is covered by vegetation and not characterized by scarp features indicates Sinkhole_1 is predominantly a cover subsidence type of sinkhole. The Google Earth® image from April 2003, shows a small surface depression to the north of the main circular depression. The steep angle and the lack of vegetation/grass cover on the scarp in the collapse feature suggest that this collapse feature. Cover collapse is a typical feature of sinkhole development in cohesive soils where the covering sediments contain significant amount of clay. The sediments spall into a cavity and as spalling continues, the cohesive covering sediments form a structural arch and eventually the cavity breaches the ground surface, resulting in sudden and dramatic collapse usually with steep angle scarps.

The series of historical images indicate that Sinkhole_1 is not an instantaneous collapse type of sinkhole; rather it appears to have developed gradually and evolved over time. Sinkhole_1 is therefore classified as cover subsidence. It appears to have initiated about the time the 1960 photograph was taken.

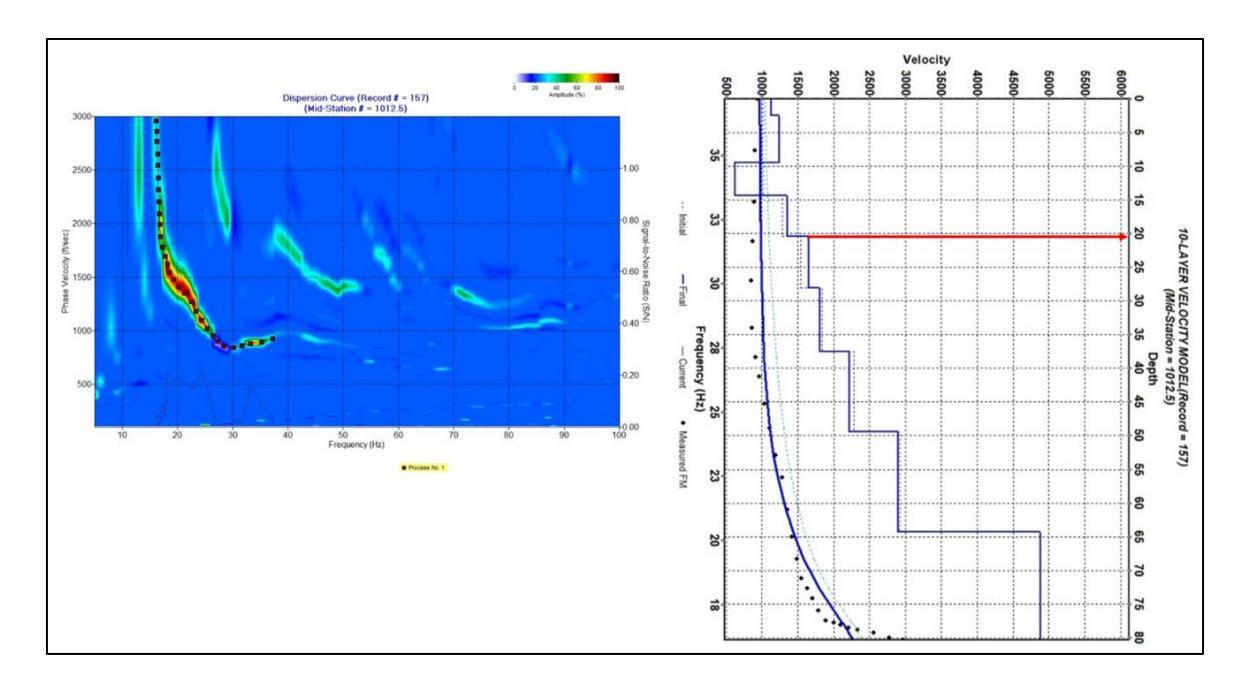
Figure 4: A dispersion curve (left); and 1-D shear wave velocity profile (right) of MASW5 presented as sample; acquisition parameters used are 10ft (3.05m) off-set, 5ft(1.52m) geophone spacing, and aligned E-W. Red color arrow indicates interpreted depth to top of rock.

Multichannel analysis of surface waves (MASW) data were acquired in proximity to Sinkhole_1 and along west-east oriented ERT profiles (Figures 4 and 5). A 24 channel geophone array connected to a seismograph is used to record the seismic data. As presented in Figure 5, six MASW profiles (MASW1, MASW2, MASW3, MASW4, MASW5 and MASW6) were generated and used to verify and constrain the interpretation of the ERT profiles. The NEHRP (National Earthquake Hazard Reduction Program) site classification chart for different geological material, as published in 2000 by the International Building code, provides a basis for the classification of subsurface materials based on their shear wave velocity values. Based on this chart and the borehole control, the shear wave velocity of soil is generally less than 1200feet/sec (366m/sec). An example dispersion curve and corresponding 1-D shear wave velocity profile from MASW5 is presented as Figure 4.

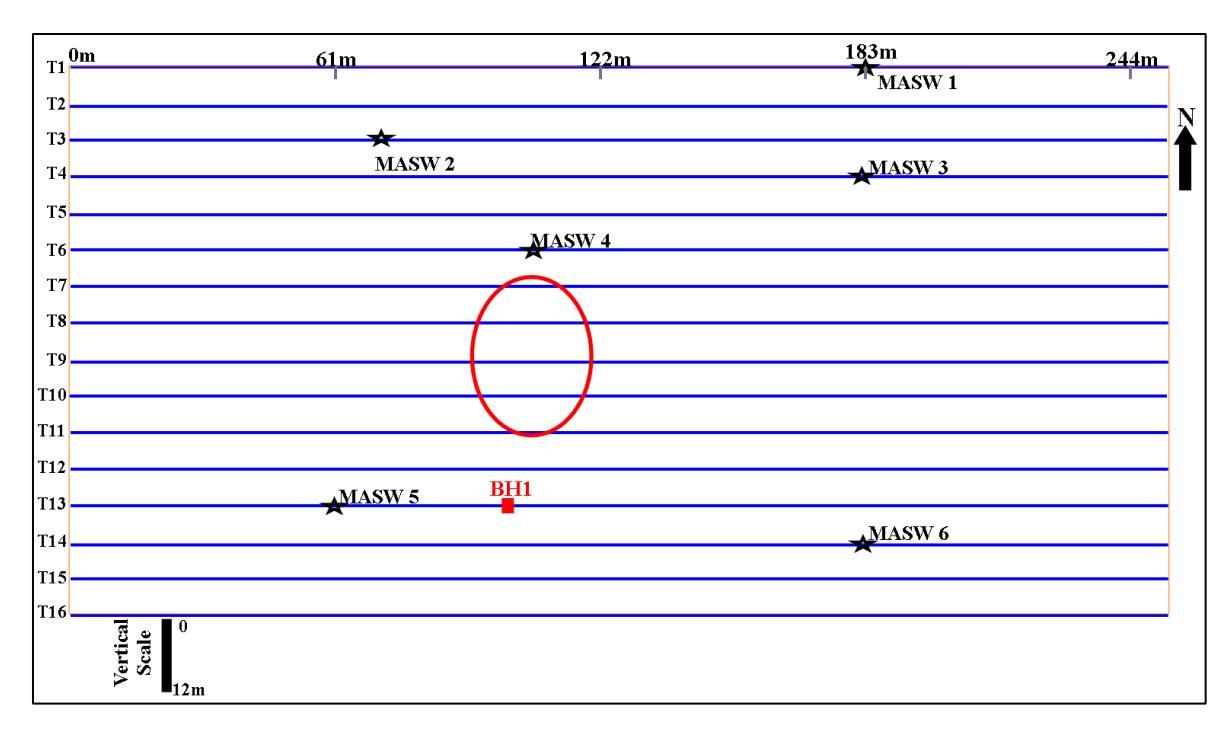
Figure 5: Alignment and location of acquired geophysical data and borehole control: West-east oriented blue lines represent ERT traverses (254.5m long each). The red color circle represents the approximate location of the surface expression of Sinkhole_1.

The borehole (BH1) was drilled along ERT profile T13 and ties at 97.5m mark on the profile (Figure 5 and 6a). It was drilled to a depth of 30m below ground surface. The first 2m comprises red clay residuum with chert, with brown silty loam with chert from 0 - 1.1m; 1.1m - 1.8m comprises red silty high plasticity clay, and finally 1.8m - 2m reveals low plasticity clay. Underlying the residual soil is Burlington-Keokuk Limestone, characterized, in core specimens, by numerous horizontal fractures. The rock quality was found to be fair to excellent.

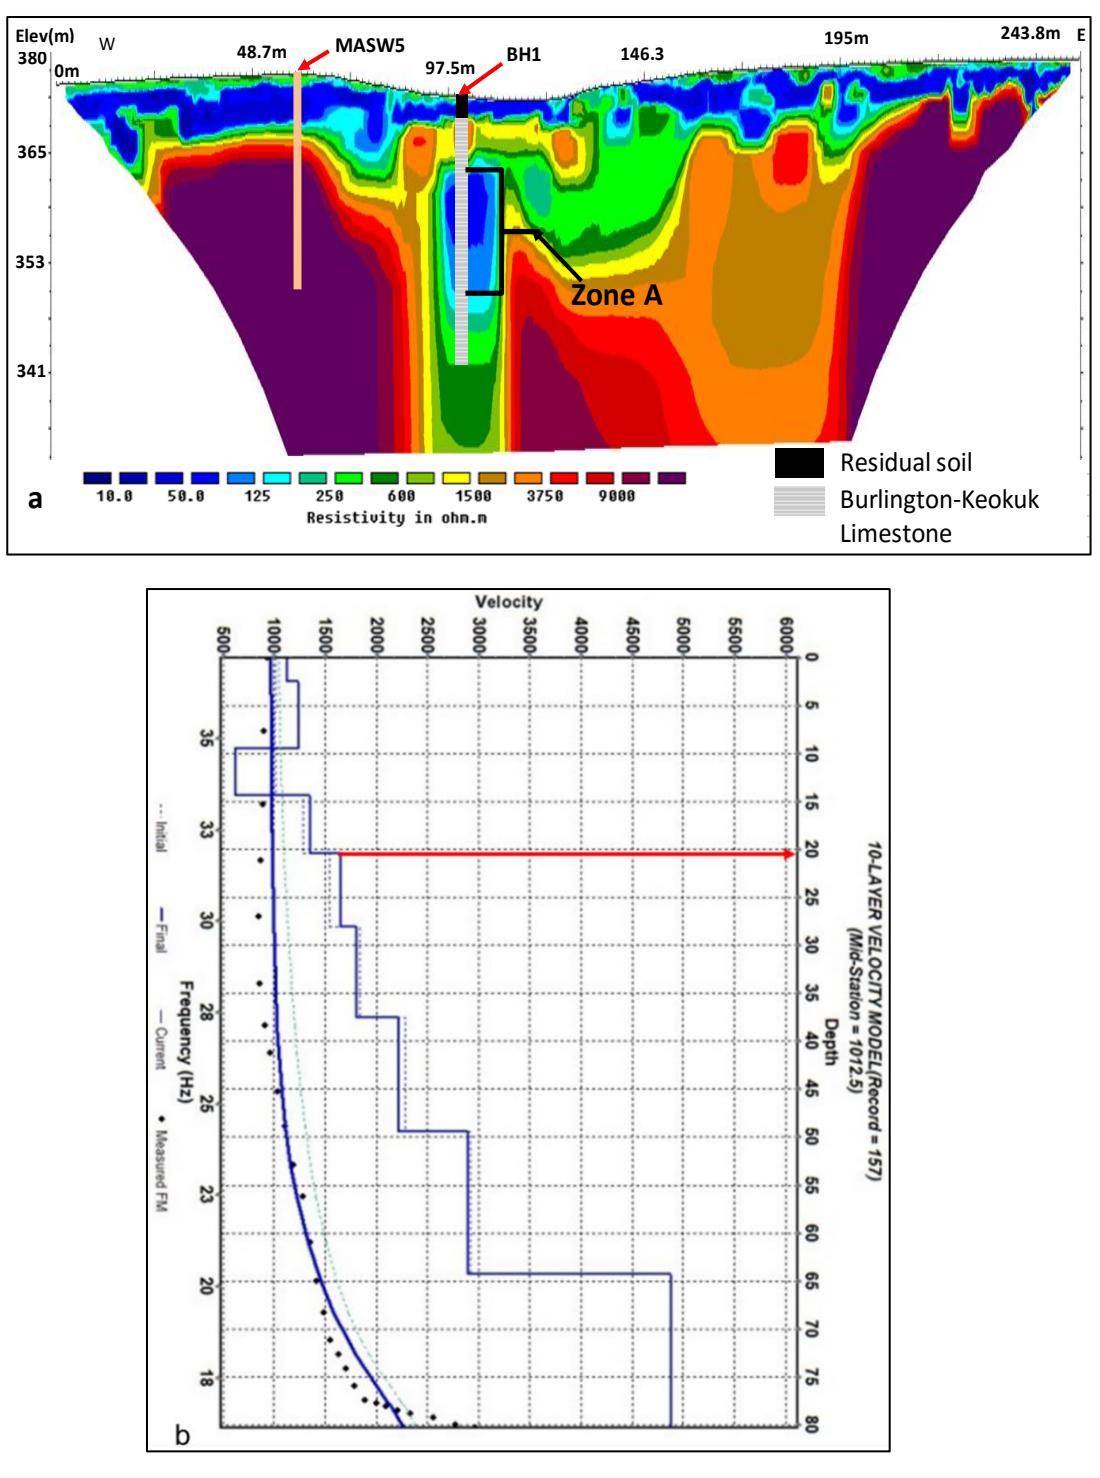
Figure 6: (a) ERT profile T13 with overlaid MASW5 and borehole (BH1). MASW5 tied T13 at the 61m mark; BH1 ties T13 at the 100m mark; (b) MASW5 1-D shear wave velocity profile. MASW depth to top of weathered rock ("acoustic" top of rock) is 20.5ft (6.2m). Red color line on Figure 6b indicates interpreted depth to top of rock.

The borehole control and MASW interpretations were superposed on the respective ERT profiles to help verify the interpretations of the electrical resistivity images. Based on the borehole data (BH1) (Figure 6a), the top of weathered rock corresponds approximately to the 125 ohm-m resistivity contour interval on ERT profile T13. Therefore, the resistivity contour value of 125 ohm-m is interpreted as the top of weathered rock on all of the other ERT profiles. Further, BH1 overlain (superposed on T13; Figure 6a) indicates that the zone of relatively low electrical resistivity (Zone A) is not a soil/water filled cavity, but rather fractured and weathered rock with fair to good quality. Therefore, the relatively low resistivity values (less than 125 ohm-m) are attributed to the presence of moisture and/or clay filled fractures. Hence, Zone A is interpreted as a moist fractured rock with some clay infilling fractures. MASW5 ties ERT T13 at 61m mark (Figure 6). The "resistivity" top of weathered rock at the MASW5 location is estimated to be 20ft (6.1m). The 1-D shear wave velocity profile in MASW5 (Figure 6b) shows an abrupt increase of velocity from 1300ft/sec (396m/sec) to 1650ft/sec (503m/sec) at a depth of 20.5ft (6.2m). This increase presumably marks the boundary between dense residual soil and the top of weathered rock and is interpreted as the "acoustic" top of rock. The additional acquired MASW data also correlate with ERT profiles, in terms of estimated depths to top of rock. Figure 7a shows MASW1 tied to the ERT profile T1 at 183m mark; the "resistivity" and "acoustic" top of weathered rock are 2.4m and 2.1m respectively. In Figure 7b, Zone B has very low electrical resistivity (less than 125 ohm-m), but its average shear wave velocity in MASW4 is about 1800ft/sec (549m/s). Similarly, the low resistivity zone (Zone C) in Figure 7c, is characterized by a shear wave velocity ranging from 1450ft/sec (442m/sec) to 1800ft/sec (549m/sec). These values of shear wave velocity are consistent with that of fractured rock. Moreover, strata with comparable resistivity values and similar geological conditions encountered in the borehole was fractured rock (Figure 6a). Hence the most plausible interpretations of zones B and C is that they are zones of fractured rock probably with moist clay infill.

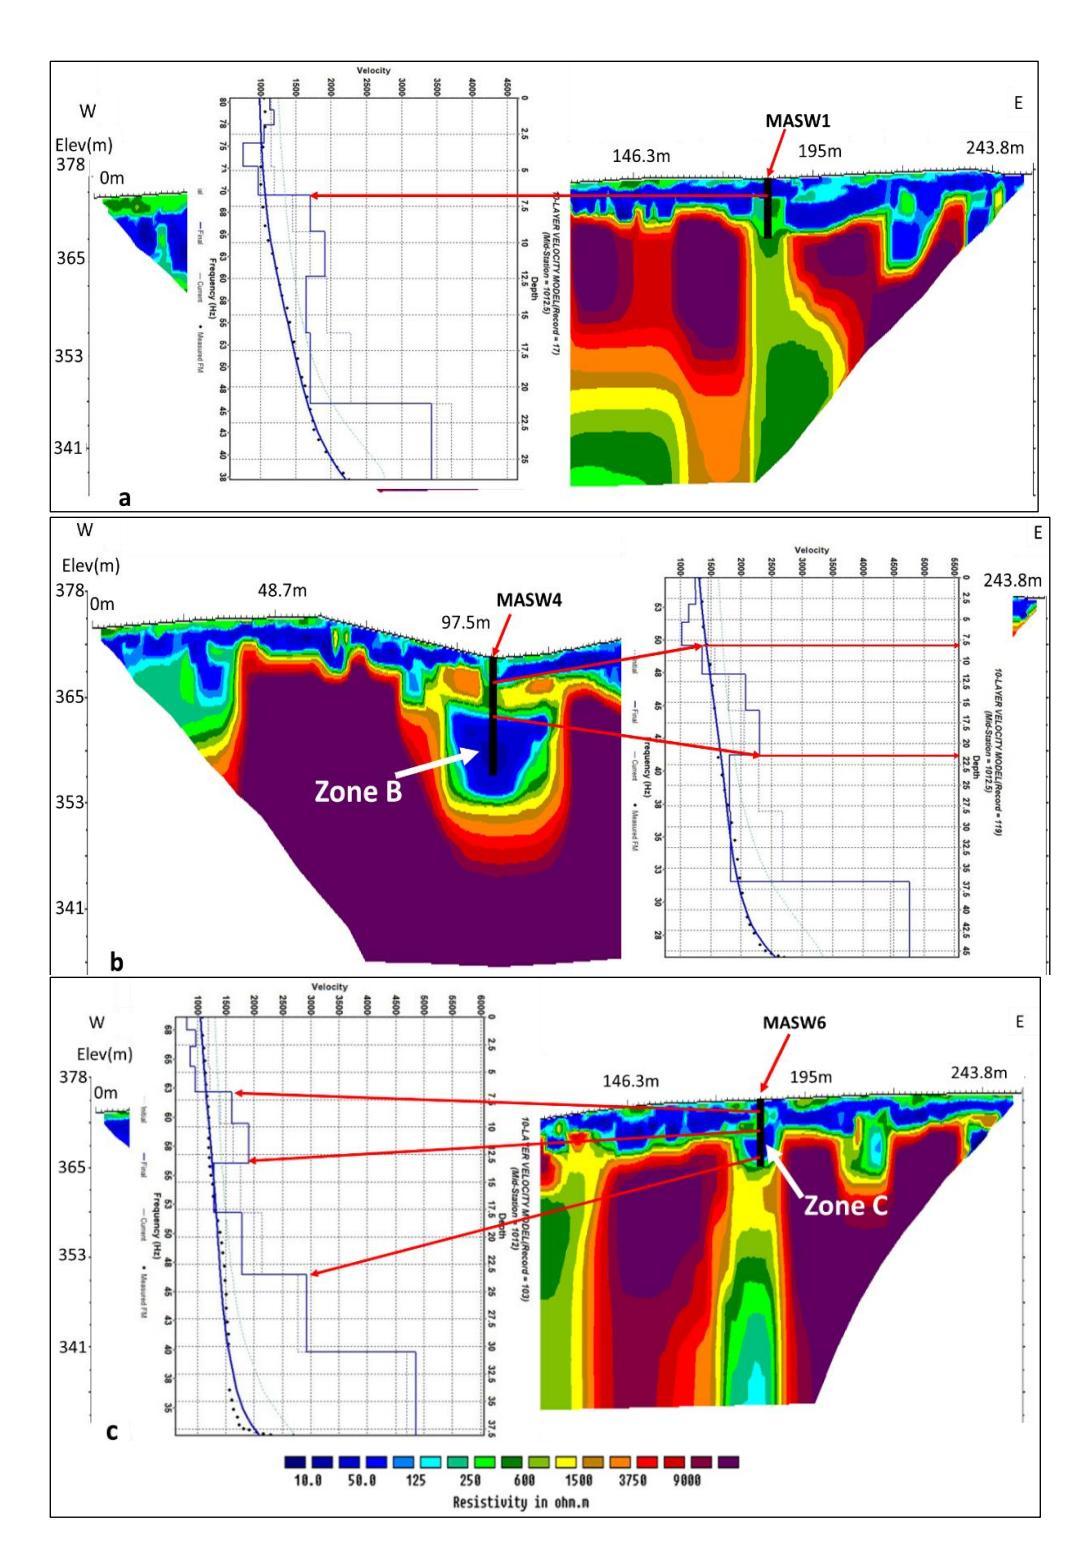
Figure 7: Correlation of the interpretation of ERT and MASW. The acquisition parameters: Offset, geophone spacing and alignment used are as follows in MASW1, 10ft (3m), 2.5ft (0.76m), N-S); in MASW4, 10ft (3m), 5ft (1.52m), E-W), and in MASW6, 10ft (3m), 5ft (1.52m), N-S).

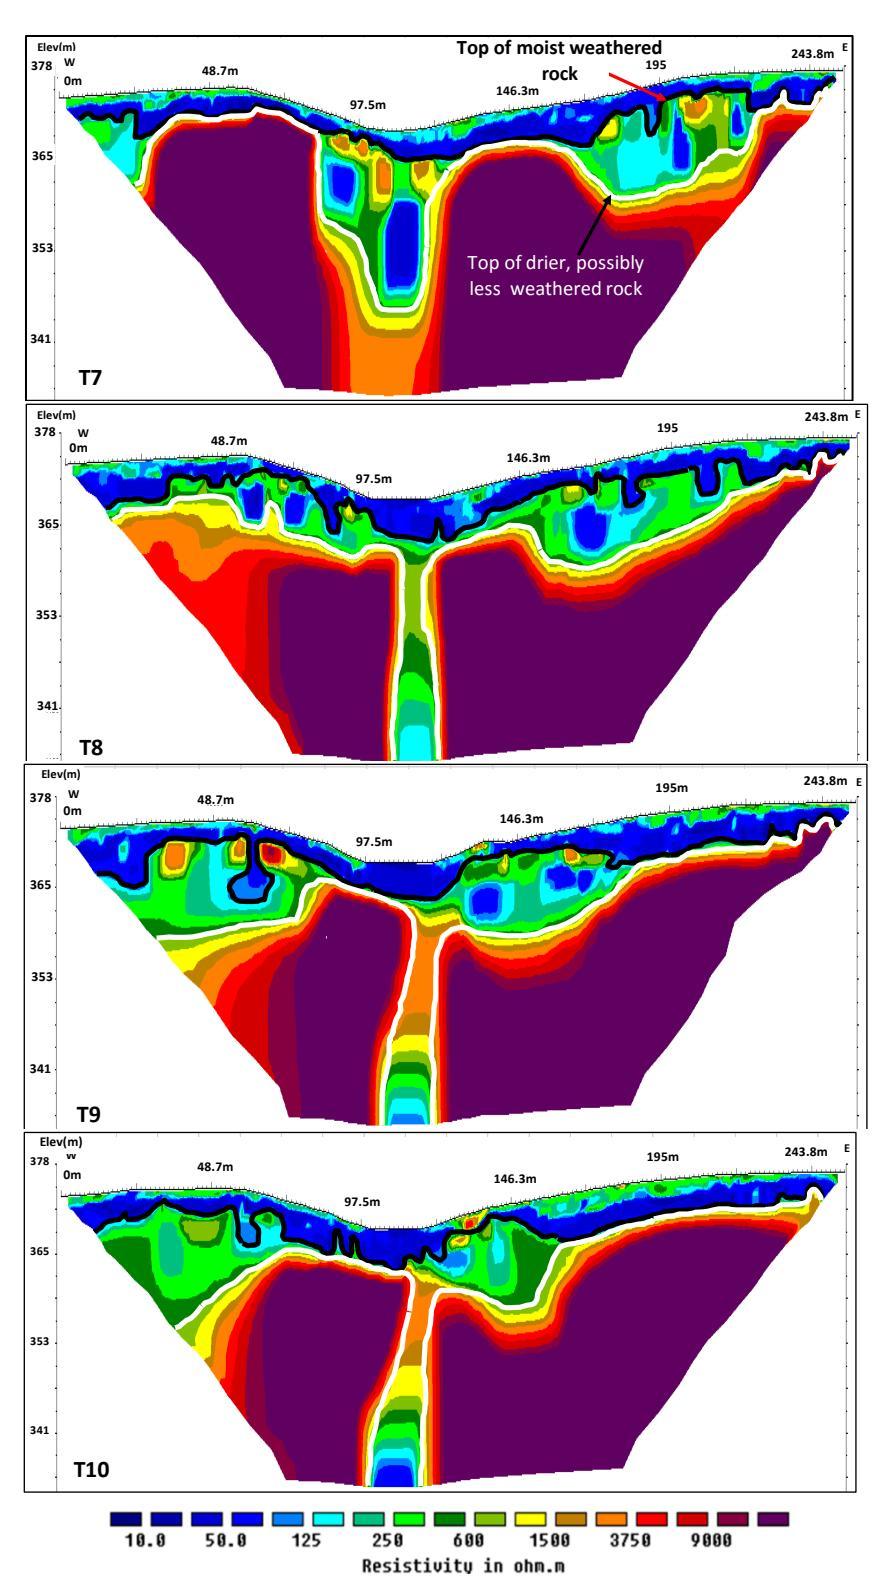
Figure 8: 2D-ERT profiles (T7, T8, T9 and T10) with interpreted top of moist weathered rock and top of drier, possibly less weathered rock. The labels given for the white and black lines in T7 are the same for T8, T9 and T10.

the sinkhole (T7, T8, T9, and T10), with interpreted depths to moist weathered rock and depths to drier, possibly less weathered rock, are shown as Figure 8.

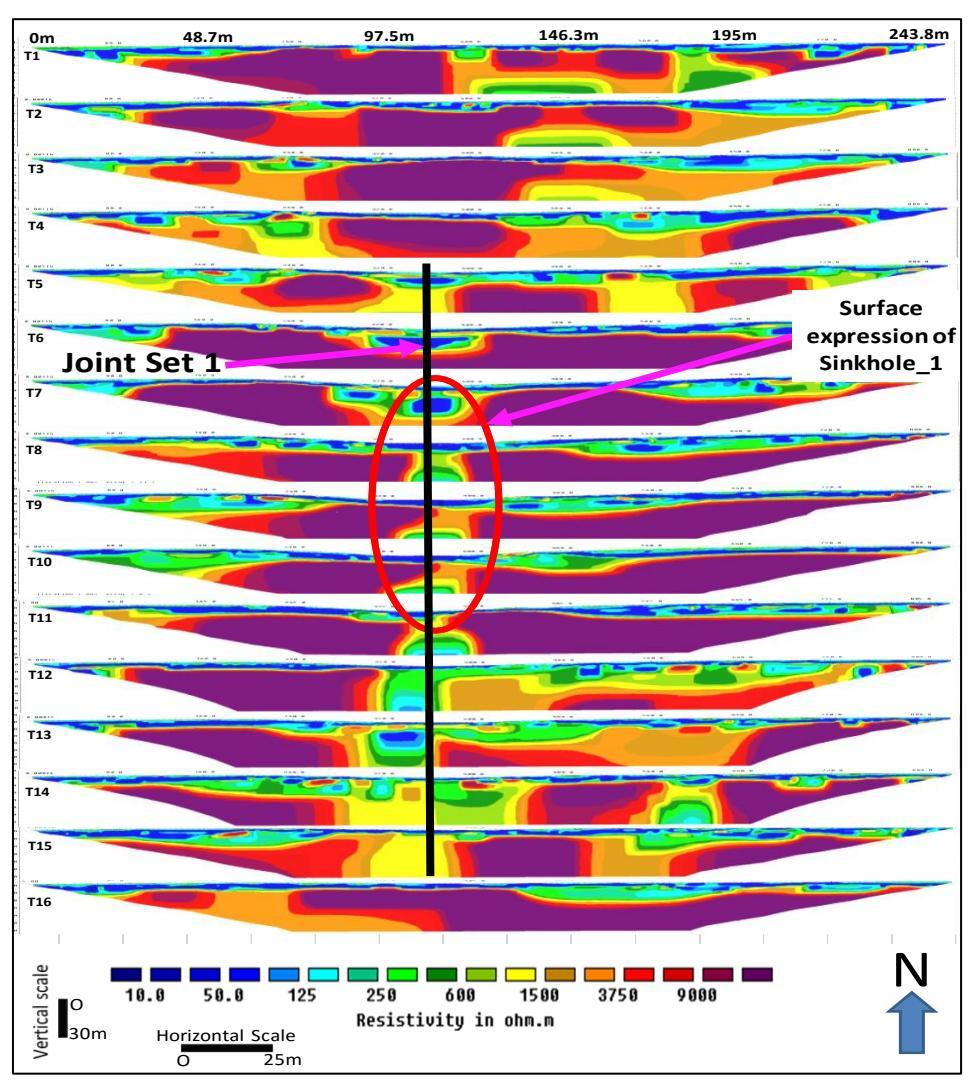
Figure 9: Parallel alignment of 16 W-E oriented 2D-ERT profiles with an approximate location of surface expression of Sinkhole_1 (in red). Each ERT profile has a length of 835ft (254.5m). Horizontal scale and vertical scale are not the same.

A linear, north-south oriented zone of relatively low resistivity that extends through Sinkhole_1 is readily identified on Figure 9. This linear feature (labeled as joint set 1 in Figure 9) could be a zone of more intense fracturing (i.e. north-south trending joint set). Alternatively, in as much as the zone underlies a natural north-south trending surface drainage pathway, this zone of low resistivity could simply be the result of moisture with piped fines percolating into the subsurface over an extended period of time presumably with some attendant solution-widening.

In addition to the prominent north-south oriented linear feature (joint set 1), other roughly linear trends of low resistivity anomalies with different orientations are also observed in Figure 9. These anomalies are not visually prominent enough and also not well defined linear features to be interpreted

as joint sets. However, their general linear trend gives an insight into the possibility of presence of other joint sets or lineaments.

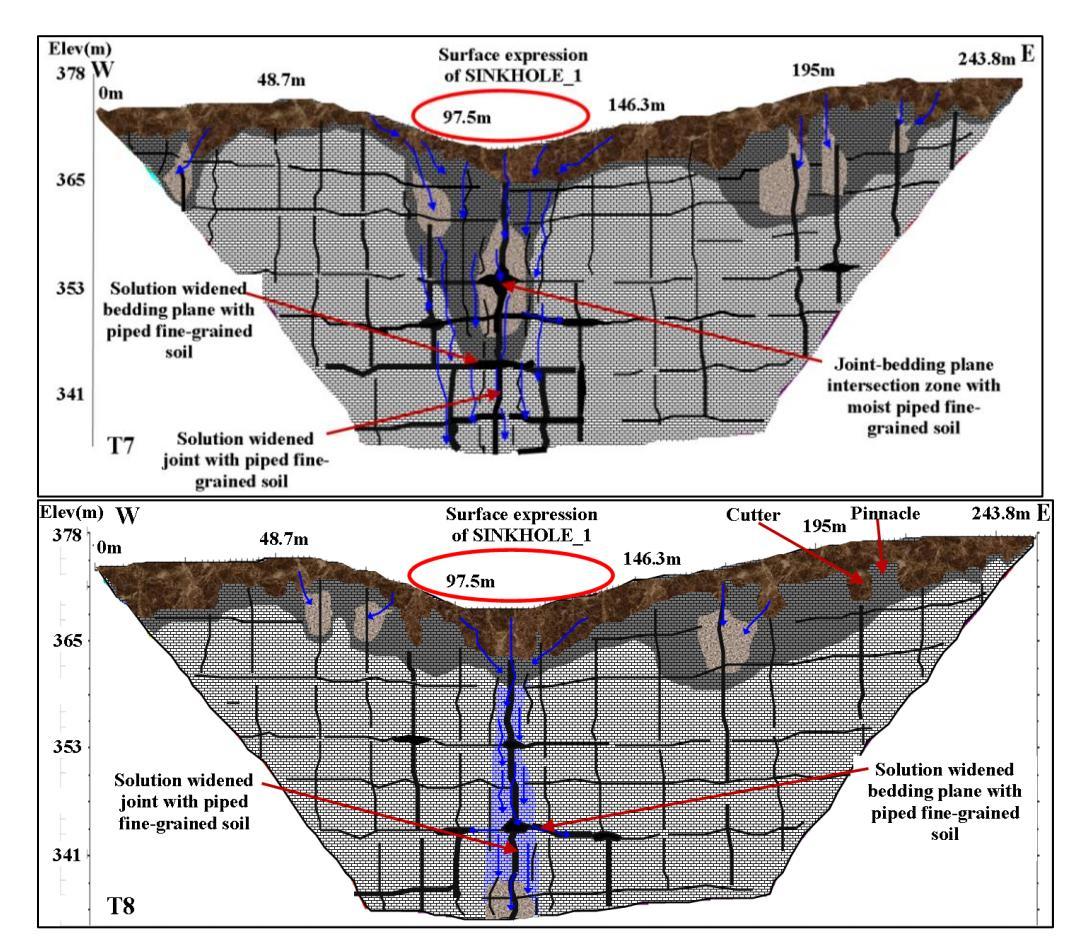
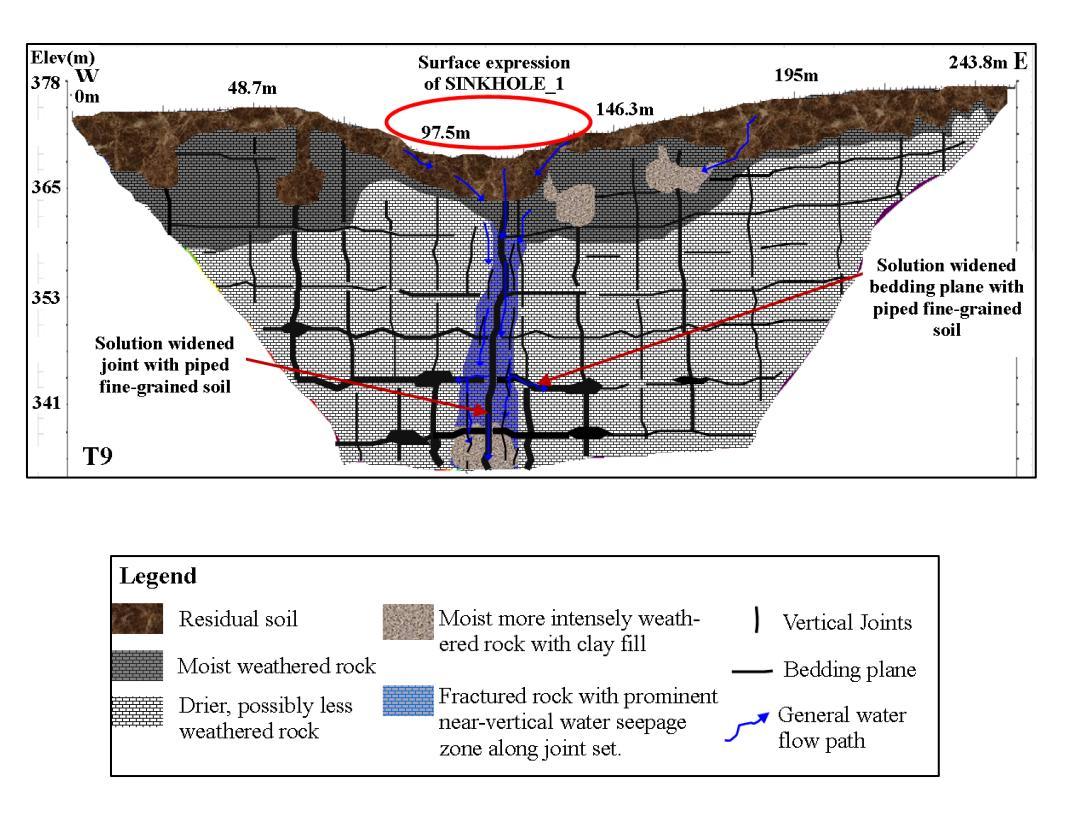
Figure 10: Geological model of the subsurface structure of Sinkhole_1, reconstructed from interpreted 2D-ERT images; T7, T8, T9 and borehole control and MASW. Horizontal and vertical scale are not the same.

The interpreted 2D-resistivity profiles (T7, T8, and T9) together with information from the borehole log were used to generate geological models depicting the subsurface structure of Sinkhole_1 (Figure10.T7, T8 and T9). Sinkholes develop as a result of interrelated processes, including bedrock dissolution, rock collapse, soil down-washing/piping and soil collapse. Any one or more of these processes may lead to the development of a sinkhole. The bedrock structure underneath the surface expression of Sinkhole_1 (Figure 10) does not show any sign of major rock collapse. In all the three images (Figure 10), there are zones interpreted as moist, intensely weathered rock with clay fill at various depths beneath and in proximity to the surface expression of Sinkhole_1. This implies that the major process involved in the development of the sinkhole is downward piping of fine-grained sediments, which fill existing and/or developing fractures. As mentioned in previously, the clay residuum has chert fragments and is not as cohesive as it would be expected from a more uniform clay soil. Hence, it is concluded that the sinkhole development involved predominantly a cover subsidence expression of the sinkhole, plus the nature of the overburden material, Sinkhole_1 is classified as predominantly a cover subsidence sinkhole.
